# Access Compliance Report

## Public Rights-of-Way

### (Curb Ramps)

Intersection ID: 15247	Main Street: E_INDEPENDENCE_BV	Cross Street: EASTWAY_DR_RA	Location: SW
ADA ID: 013B839B5BF2	Ramp Type: Perp	Initial Pass/Fail: Pass	Overall Compliance: No
Severity Score: 20			
Codes/Mitigation Info/Possible Solution		Field Measurements/Component Compliance

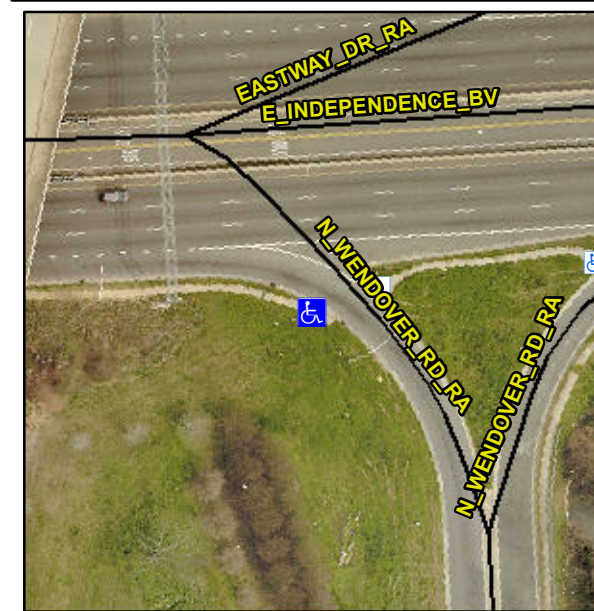
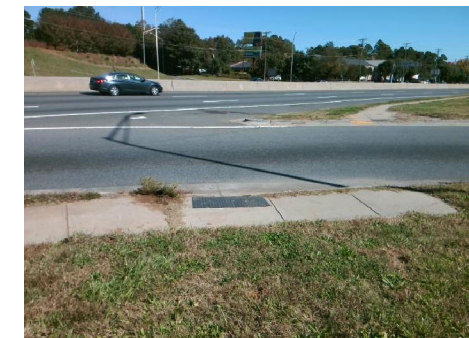
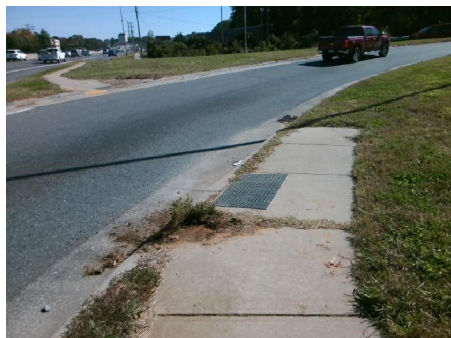
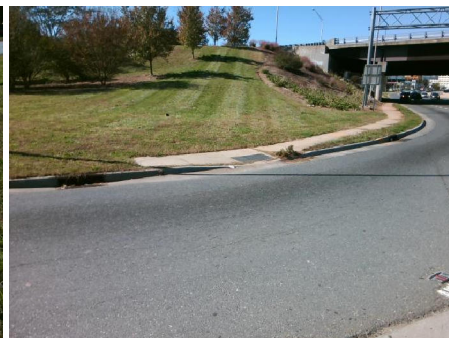
**Not Found, R304.2.1, R304.2.2-Perp, R304.3.2-Para, R304.5.3, R305.1.4, R305.2, R302.7, R302.7.2**

Compliance	Description	Data	Compliance	Description	Data
N/A	Ramp Length (in)	61.0	Yes	Ramp Slope (%)	6.6
Yes	Ramp Width (in)	50.0	Yes	Ramp XSlope (%)	1.1
N/A	Flare Type LT	Sloped	N/A	Flare Type RT	N/A
N/A	Flare Slope LT (%)	3.8	Yes	Flare Slope RT (%)	7.5
N/A	Flare Traversable LT?	Yes	N/A	Flare Traversable RT?	Yes
No	Landing Length (in)	N/A	Yes	DWS Provided?	Yes
No	Landing Width (in)	N/A	Yes	DWS Contrast?	Yes
No	Landing Slope (%)	N/A	Yes	DWS Length (in)	25.5
No	Landing X Slope (%)	N/A	No	DWS Full Width?	No
N/A	Landing Curb? (Y/N)	No	No	DWS Offset (in)	2.5
N/A	Shared Landing?	No			
No	Gutter Ponding?	Yes	Yes	Gutter Slope (%)	2.6
No	Gutter Lip Ht (in)	0.5	Yes	Gutter X Slope (%)	1.2
N/A	Painted X Walk1?	No	N/A	Painted X Walk2?	N/A
	X Walk 1 Direction	To NE		X Walk 2 Direction	N/A
N/A	X Walk 1 Width (in)	N/A	N/A	X Walk 2 Width (in)	N/A
	X Walk 1 Slope (%)	5.2		X Walk 2 Slope (%)	N/A
	X Walk 1 X Slope (%)	2.1		X Walk 2 X Slope (%)	N/A

N/A	Ramp inside XWalk1?	N/A	N/A	Ramp inside XWalk2?	N/A
	Road Slope (%)	N/A	N/A	Clear Space?	Yes
	Road X Slope (%)	N/A	N/A	Clear Space to XWalk (in)	N/A
Yes	Any Obstructions?	No	Yes	Storm Grate/Utility Hazard?	No
	Obstruction Type			Storm Grate/Utility Type	
		N/A			N/A
			Yes	Surface Condition? (G/P)	Good

**Remove & Replace Entire Ramp.**
