# Access Compliance Report

## Public Rights-of-Way

### (Curb Ramps)

Intersection ID: 21721	Main Street: SARDIS_RD_NORTH	Cross Street: RITTER_DR	Location: W
ADA ID: 014A3AAE2B66	Ramp Type: ParaDiag	Initial Pass/Fail: Fail	Overall Compliance: No
Severity Score: 26.25			
Codes/Mitigation Info/Possible Solution		Field Measurements/Component Compliance

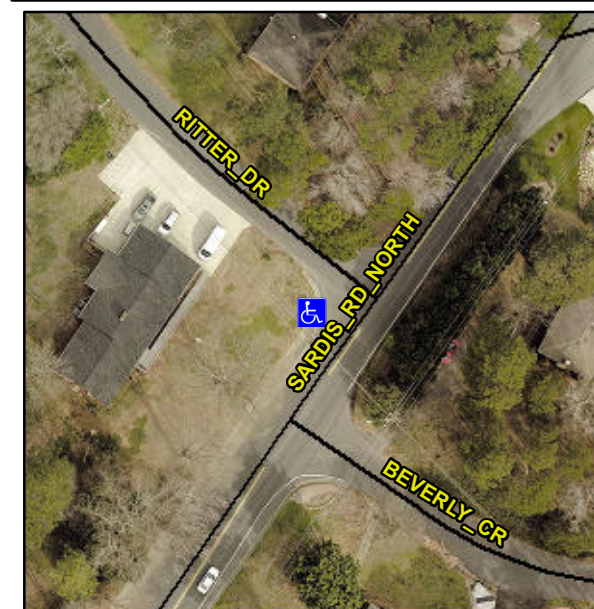
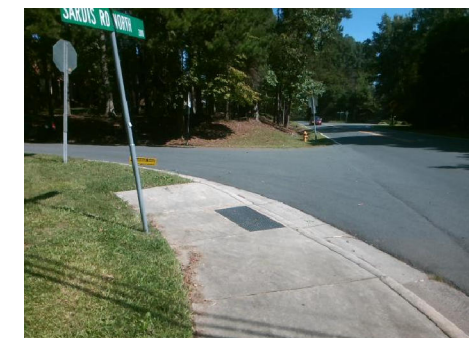
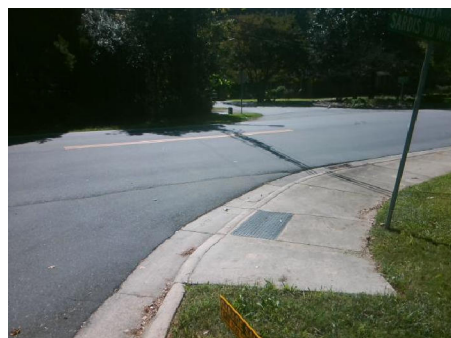
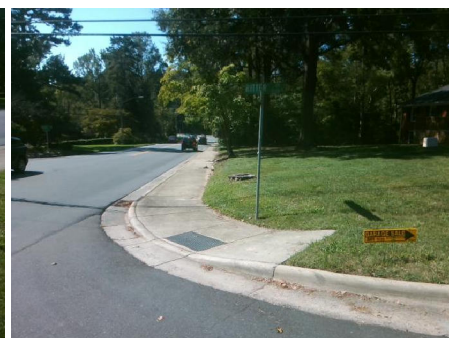
Compliance	Description	Data	Compliance	Description	Data
N/A	Ramp Length LT (in)	N/A	N/A	Ramp Length RT (in)	50.0
N/A	Ramp Width LT (in)	N/A	Yes	Ramp Width RT (in)	72.0
N/A	Ramp Slope LT (%)	N/A	No	Ramp Slope RT (%)	19.9
N/A	Ramp XSlope LT (%)	N/A	No	Ramp XSlope RT (%)	3.1
N/A	Landing Length (in)	N/A	N/A	DWS Provided?	N/A
N/A	Landing Width (in)	N/A	N/A	DWS Contrast?	N/A
N/A	Landing Slope (%)	N/A	N/A	DWS Length (in)	N/A
N/A	Landing X Slope (%)	N/A	N/A	DWS Full Width?	N/A
N/A	Landing Curb? (Y/N)	N/A	N/A	DWS Offset (in)	N/A
N/A	Shared Landing?	N/A			
N/A	Gutter Ponding?	N/A	N/A	Gutter Slope (%)	N/A
N/A	Gutter Lip Ht (in)	N/A	N/A	Gutter X Slope (%)	N/A
N/A	Painted X Walk1?	No	N/A	Painted X Walk2?	No
	X Walk 1 Direction	To SE		X Walk 2 Direction	To NE
N/A	X Walk 1 Width (in)	N/A	N/A	X Walk 2 Width (in)	N/A
	X Walk 1 Slope (%)	0.3		X Walk 2 Slope (%)	10.1
	X Walk 1 X Slope (%)	8.9		X Walk 2 X Slope (%)	4.8
N/A	Ramp inside XWalk1?	N/A	N/A	Ramp inside XWalk2?	N/A

Road Slope (%)	7.2	N/A	Clear Space?	N/A
	Road X Slope (%)	5.6	N/A	Clear Space to XWalk (in)	N/A
N/A	Any Obstructions?	N/A	N/A	Storm Grate/Utility Hazard?	N/A
	Obstruction Type			Storm Grate/Utility Type	
		N/A			N/A
			Yes	Surface Condition? (G/P)	Good
			N/A	Curb Slope (%)	4.4

**Remove & Replace Curb Ramp With Two New Directional Ramps or Equivalent.**

**R304.3.2, R304.5.3**
