Access Compliance Report

Public Rights-of-Way

(Curb Ramps)

Intersection ID: 17480	Main Street: MIDDLEBURG_DR	Cross Street: CITY_VIEW_DR	Location: NE
ADA ID: 0152602640C1	Ramp Type: PerpDiag	Initial Pass/Fail: Fail	Overall Compliance: No
Severity Score: 25			
Codes/Mitigation Info/Possible Solution		Field Measurements/Component Compliance

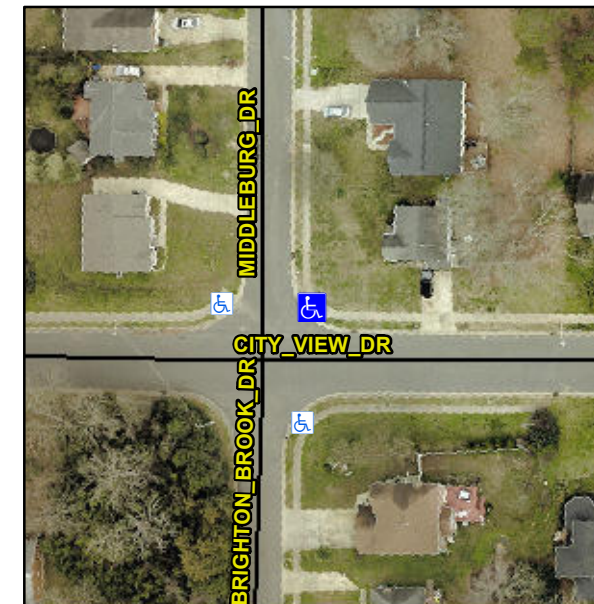
Compliance	Description	Data	Compliance	Description	Data
N/A	Ramp Length (in)	95.0	Yes	Ramp Slope (%)	5.6
Yes	Ramp Width (in)	48.0	No	Ramp XSlope (%)	7.9
N/A	Flare Type LT	N/A	N/A	Flare Type RT	N/A
N/A	Flare Slope LT (%)	N/A	N/A	Flare Slope RT (%)	N/A
N/A	Flare Traversable LT?	N/A	N/A	Flare Traversable RT?	N/A
N/A	Landing Length (in)	N/A	N/A	DWS Provided?	N/A
N/A	Landing Width (in)	N/A	N/A	DWS Contrast?	N/A
N/A	Landing Slope (%)	N/A	N/A	DWS Length (in)	N/A
N/A	Landing X Slope (%)	N/A	N/A	DWS Full Width?	N/A
N/A	Landing Curb? (Y/N)	N/A	N/A	DWS Offset (in)	N/A
N/A	Shared Landing?	N/A			
N/A	Gutter Ponding?	N/A	N/A	Gutter Slope (%)	N/A
N/A	Gutter Lip Ht (in)	N/A	N/A	Gutter X Slope (%)	N/A
N/A	Painted X Walk1?	No	N/A	Painted X Walk2?	No
	X Walk 1 Direction	To NW		X Walk 2 Direction	To SW
N/A	X Walk 1 Width (in)	N/A	N/A	X Walk 2 Width (in)	N/A
	X Walk 1 Slope (%)	4.2		X Walk 2 Slope (%)	6.8
	X Walk 1 X Slope (%)	4.7		X Walk 2 X Slope (%)	4.0

N/A	Ramp inside XWalk1?	N/A	N/A	Ramp inside XWalk2?	N/A
	Road Slope (%)	7.2	N/A	Clear Space?	N/A
	Road X Slope (%)	0.0	N/A	Clear Space to XWalk (in)	N/A
N/A	Any Obstructions?	N/A	N/A	Storm Grate/Utility Hazard?	N/A
	Obstruction Type			Storm Grate/Utility Type	
		N/A			N/A
		Yes		Surface Condition? (G/P)	Good

Possible Solutions:

Remove & Replace Curb Ramp With Two New Directional Ramps or Equivalent.

R304.5.3

\$ 3200.00
