# Access Compliance Report

## Public Rights-of-Way

### (Curb Ramps)

| Intersection ID: 8111 | Main Street: CINDERELLA_RD | Cross Street: THORNWOOD_RD | Location: NE |

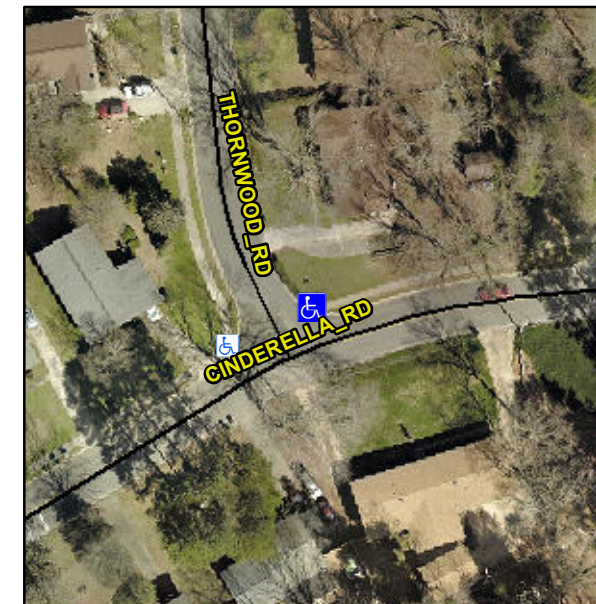
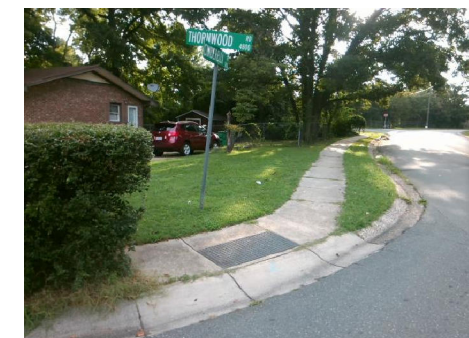
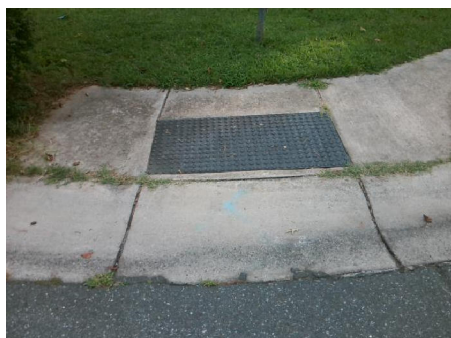
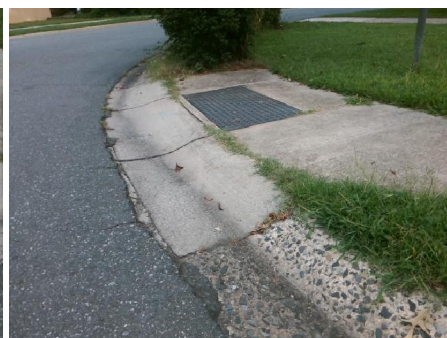
**Not Found, R304.5.1, R304.5.3**

| Compliance | Description | Data | Compliance | Description | Data |
|---|---|---|---|---|---|
| N/A | Ramp Length (in) | 46.0 | Yes | Ramp Slope (%) | 5.2 |
| No | Ramp Width (in) | 47.5 | No | Ramp XSlope (%) | 3.4 |

**Remove & Replace Entire Ramp.**
