# Access Compliance Report

## Public Rights-of-Way

### (Curb Ramps)

Intersection ID: 42665	Main Street: WALLACE_AV	Cross Street: WALLACE_GLEN_DR	Location: S
ADA ID: 016525D72794	Ramp Type: Perp	Initial Pass/Fail: Fail	Overall Compliance: No
Severity Score: 13.75			
Codes/Mitigation Info/Possible Solution		Field Measurements/Component Compliance

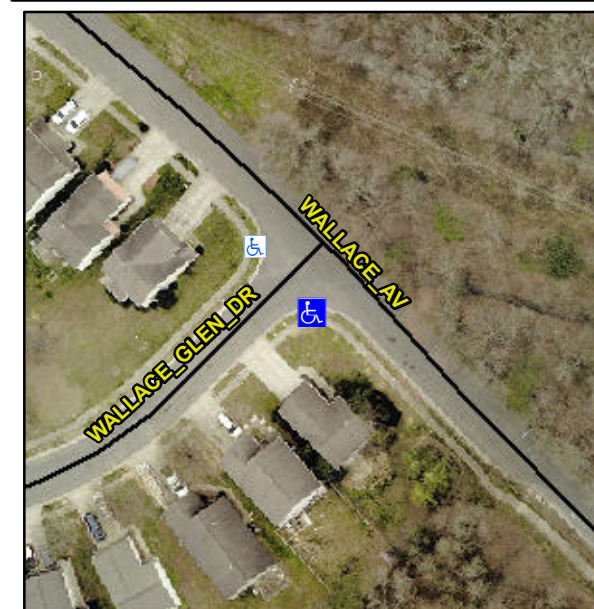
**Not Found, R304.2.2, R304.5.3**

Compliance	Description	Data	Compliance	Description	Data
N/A	Ramp Length (in)	49.0	No	Ramp Slope (%)	8.4
Yes	Ramp Width (in)	48.0	No	Ramp XSlope (%)	3.0
N/A	Flare Type LT	N/A	N/A	Flare Type RT	N/A
N/A	Flare Slope LT (%)	N/A	N/A	Flare Slope RT (%)	N/A
N/A	Flare Traversable LT?	N/A	N/A	Flare Traversable RT?	N/A
N/A	Landing Length (in)	N/A	N/A	DWS Provided?	N/A
N/A	Landing Width (in)	N/A	N/A	DWS Contrast?	N/A
N/A	Landing Slope (%)	N/A	N/A	DWS Length (in)	N/A
N/A	Landing X Slope (%)	N/A	N/A	DWS Full Width?	N/A
N/A	Landing Curb? (Y/N)	N/A	N/A	DWS Offset (in)	N/A
N/A	Shared Landing?	N/A			
N/A	Gutter Ponding?	N/A	N/A	Gutter Slope (%)	N/A
N/A	Gutter Lip Ht (in)	N/A	N/A	Gutter X Slope (%)	N/A
N/A	Painted X Walk1?	No	N/A	Painted X Walk2?	N/A
	X Walk 1 Direction	To NW		X Walk 2 Direction	N/A
N/A	X Walk 1 Width (in)	N/A	N/A	X Walk 2 Width (in)	N/A
	X Walk 1 Slope (%)	0.7		X Walk 2 Slope (%)	N/A
	X Walk 1 X Slope (%)	2.5		X Walk 2 X Slope (%)	N/A

N/A	Ramp inside XWalk1?	N/A	N/A	Ramp inside XWalk2?	N/A
	Road Slope (%)	N/A	N/A	Clear Space?	N/A
	Road X Slope (%)	N/A	N/A	Clear Space to XWalk (in)	N/A
N/A	Any Obstructions?	N/A	N/A	Storm Grate/Utility Hazard?	N/A
	Obstruction Type			Storm Grate/Utility Type	
		N/A			N/A
			Yes	Surface Condition? (G/P)	Good

Possible Solutions:

**Remove & Replace Entire Ramp.**
