## Access Compliance Report Public Rights-of-Way (Curb Ramps)

Intersection ID: 24099	Main Street: ARBOR_POINTE_DR			Street:	FOUR_ACRE_CT	Location:	SW		
ADA ID: 016F53017EDF	Ramp Type: PerpDiag			Initial Pass/Fail: Fail Overall Compliance: No				o Severity Score:	22.5
Codes/Mitigation Info/Possible Solution				Field Measurements/Component Compliance					
		Possible Solutions:		Compliance Description			Data Compliance Description		Data

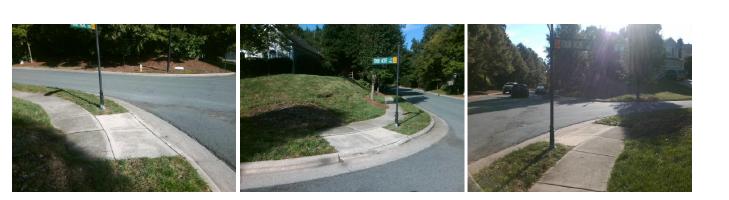
C. A.		Remove & Replace Curb Ram	With	N/A	Ramp Length (in)	47.0	No	Ramp Slope (%)	11.5
		Two New Directional Ramps or		No	Ramp Width (in)	40.0	No	Ramp XSlope (%)	4.1
		Equivalent.		N/A	Flare Type LT	N/A	N/A	Flare Type RT	N/A
				N/A	Flare Slope LT (%)	N/A	N/A	Flare Slope RT (%)	N/A
				N/A	Flare Traversable LT?	N/A	N/A	Flare Traversable RT?	N/A
ARBOR POINTE DR				N/A	Landing Length (in)	N/A	N/A	DWS Provided?	N/A
				N/A	Landing Width (in)	N/A	N/A	DWS Contrast?	N/A
A State of the sta		N/A		N/A	Landing Slope (%)	N/A	N/A	DWS Length (in)	N/A
				N/A	Landing X Slope (%)	N/A	N/A	DWS Full Width?	N/A
				N/A	Landing Curb? (Y/N)	N/A	N/A	DWS Offset (in)	N/A
				N/A	Shared Landing?	N/A			
198 Alla Alla		PROW/ADA:		N/A	Gutter Ponding?	N/A	N/A	Gutter Slope (%)	N/A
		Not Found, R304.5.1, R304.2.		N/A	Gutter Lip Ht (in)	N/A	N/A	Gutter X Slope (%)	N/A
	19 31-1	R304.5.3		N/A	Painted X Walk1?	No	N/A	Painted X Walk2?	No

X Walk 1 Direction	To E		X Walk 2 Direction	To N
	THE REAL PROPERTY AND INCOMENTS			N/A	X Walk 1 Width (in)	N/A	N/A	X Walk 2 Width (in)	N/A
Street 1 Name	FOUR ACRE CT	•			X Walk 1 Slope (%)	1.9		X Walk 2 Slope (%)	1.9
Stop Condition-Street 2	StopSign				X Walk 1 X Slope (%)	2.6		X Walk 2 X Slope (%)	2.8
Street 2 Name	ARBOR POINTE DR			N/A	Ramp inside XWalk1?	N/A	N/A	Ramp inside XWalk2?	N/A
Stop Condition-Street 1	None				Road Slope (%)	2.4	N/A	Clear Space?	N/A
					Road X Slope (%)	2.0	N/A	Clear Space to XWalk (in)	N/A
				N/A	Any Obstructions?	N/A	N/A	Storm Grate/Utility Hazard?	N/A
		Total Cost: \$	3200.00		Obstruction Type			Storm Grate/Utility Type	
1		ψ				N/A		cloth Grato/Gunty Type	N/A
						IN/A			17/5
