Access Compliance Report

Public Rights-of-Way (Curb Ramps)

Intersection ID: 44610	Main Street: FIG_LN	Cross Street: PINYON_PINE_LN	Location: NE
ADA ID: 017897502D46	Ramp Type: PerpDiag	Initial Pass/Fail: Fail	Overall Compliance: No
Severity Score: 8.75			
Codes/Mitigation Info/Possible Solution		Field Measurements/Component Compliance

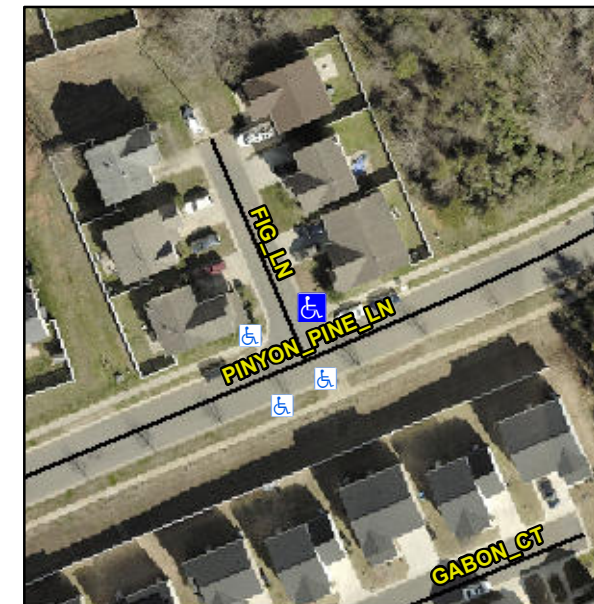
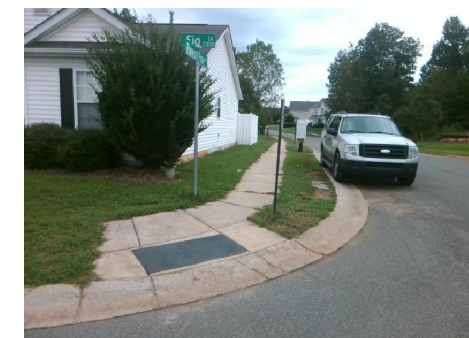
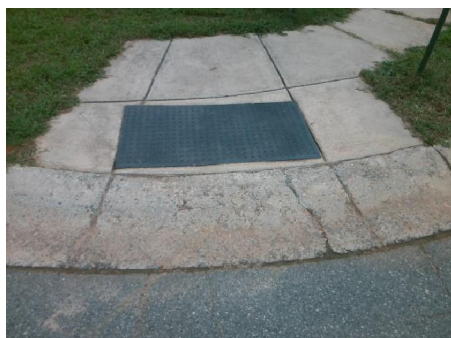
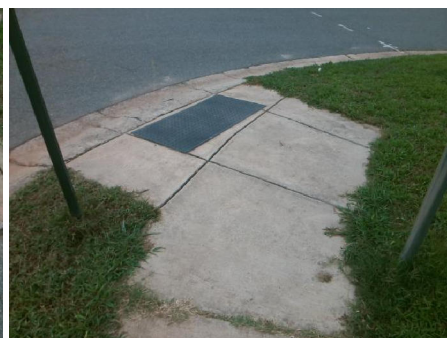
Not Found, R304.5.1

Compliance	Description	Data	Compliance	Description	Data
N/A	Ramp Length (in)	31.0	Yes	Ramp Slope (%)	6.5
No	Ramp Width (in)	42.0	Yes	Ramp XSlope (%)	1.9
N/A	Flare Type LT	N/A	N/A	Flare Type RT	N/A
N/A	Flare Slope LT (%)	N/A	N/A	Flare Slope RT (%)	N/A
N/A	Flare Traversable LT?	N/A	N/A	Flare Traversable RT?	N/A
N/A	Landing Length (in)	N/A	N/A	DWS Provided?	N/A
N/A	Landing Width (in)	N/A	N/A	DWS Contrast?	N/A
N/A	Landing Slope (%)	N/A	N/A	DWS Length (in)	N/A
N/A	Landing X Slope (%)	N/A	N/A	DWS Full Width?	N/A
N/A	Landing Curb? (Y/N)	N/A	N/A	DWS Offset (in)	N/A
N/A	Shared Landing?	N/A			
N/A	Gutter Ponding?	N/A	N/A	Gutter Slope (%)	N/A
N/A	Gutter Lip Ht (in)	N/A	N/A	Gutter X Slope (%)	N/A
N/A	Painted X Walk1?	No	N/A	Painted X Walk2?	No
	X Walk 1 Direction	To W		X Walk 2 Direction	To S
N/A	X Walk 1 Width (in)	N/A	N/A	X Walk 2 Width (in)	N/A
	X Walk 1 Slope (%)	2.3		X Walk 2 Slope (%)	4.1
	X Walk 1 X Slope (%)	2.4		X Walk 2 X Slope (%)	1.6

N/A	Ramp inside XWalk1?	N/A	N/A	Ramp inside XWalk2?	N/A
	Road Slope (%)	2.0	N/A	Clear Space?	N/A
	Road X Slope (%)	4.4	N/A	Clear Space to XWalk (in)	N/A
N/A	Any Obstructions?	N/A	N/A	Storm Grate/Utility Hazard?	N/A
	Obstruction Type			Storm Grate/Utility Type	
		N/A			N/A
		Yes		Surface Condition? (G/P)	Good

Remove & Replace Curb Ramp With Two New Directional Ramps or Equivalent.
