Access Compliance Report

Public Rights-of-Way

(Curb Ramps)

Intersection ID: 27427	Main Street: TILLEY MORRIS RD	Cross Street: DEERFIELD CREEK DR	Location: S
ADA ID: 0180AB980AB7	Ramp Type: BlendTrans1	Initial Pass/Fail: Fail	Overall Compliance: No
		Severity Score: 30

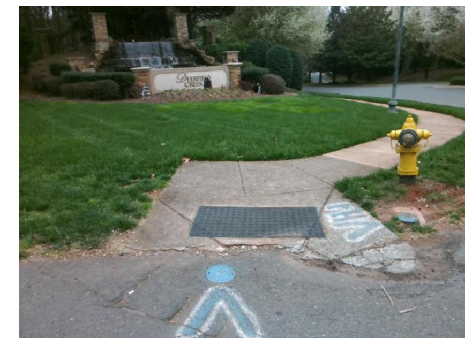
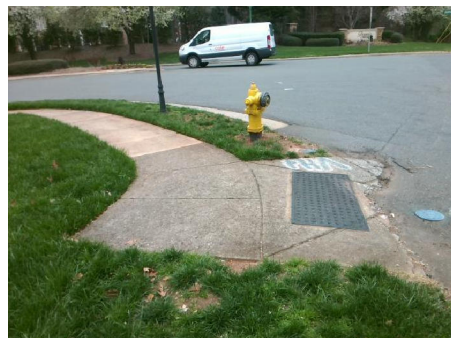
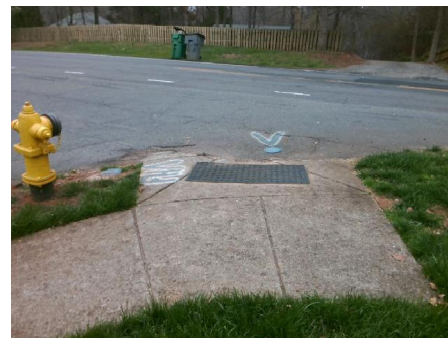
Compliance	Description	Data	Compliance	Description	Data
N/A	Ramp Length (in)	42.0	Yes	BlendTrans Slope (%)	4.0
No	Ramp Width (in)	33.0	No	BlendTrans XSlope (%)	5.1
N/A	Flare Type LT	N/A	N/A	Flare Type RT	N/A
N/A	Flare Slope LT (%)	N/A	N/A	Flare Slope RT (%)	N/A
N/A	Flare Traversable LT?	N/A	N/A	Flare Traversable RT?	N/A
N/A	Landing Length (in)	N/A	N/A	DWS Provided?	N/A
N/A	Landing Width (in)	N/A	N/A	DWS Contrast?	N/A
N/A	Landing Slope (%)	N/A	N/A	DWS Length (in)	N/A
N/A	Landing X Slope (%)	N/A	N/A	DWS Full Width?	N/A
N/A	Landing Curb? (Y/N)	N/A	N/A	DWS Offset (in)	N/A
N/A	Shared Landing?	N/A			
N/A	Gutter Ponding?	N/A	N/A	Gutter Slope (%)	N/A
N/A	Gutter Lip Ht (in)	N/A	N/A	Gutter X Slope (%)	N/A
N/A	Painted X Walk1?	No	N/A	Painted X Walk2?	N/A
	X Walk 1 Direction	To NE		X Walk 2 Direction	N/A
	X Walk 1 Width (in)	N/A		X Walk 2 Width (in)	N/A
	X Walk 1 Slope (%)	6.5		X Walk 2 Slope (%)	N/A
	X Walk 1 X Slope (%)	3.6		X Walk 2 X Slope (%)	N/A

N/A	Ramp inside XWalk1?	N/A	N/A	Ramp inside XWalk2?	N/A
	Road Slope (%)	3.6		Clear Space?	N/A
	Road X Slope (%)	6.5	N/A	Clear Space to XWalk (in)	N/A
N/A	Any Obstructions?	N/A	N/A	Storm Grate/Utility Hazard?	N/A
	Obstruction Type			Storm Grate/Utility Type	
		N/A			N/A
			Yes	Surface Condition? (G/P)	Good
			N/A	Curb Slope (%)	N/A

Remove & Replace Curb Ramp With Two New Directional Ramps or Equivalent.
