Intersection ID: 15333	Main Street: IDEAL_WY	Cross Street: WINTHROP_AV	Location:	NE
ADA ID: 0181BEDBB2C7	Ramp Type: PerpDiag	Initial Pass/Fail: Fail	Overall Compliance: No	Severity Score: 33.75

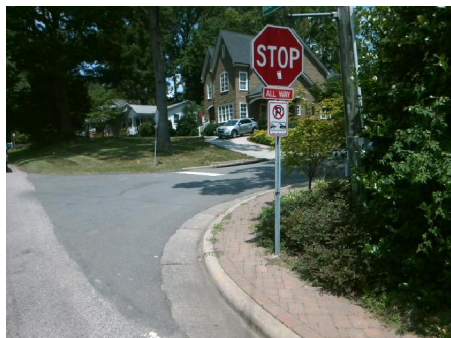
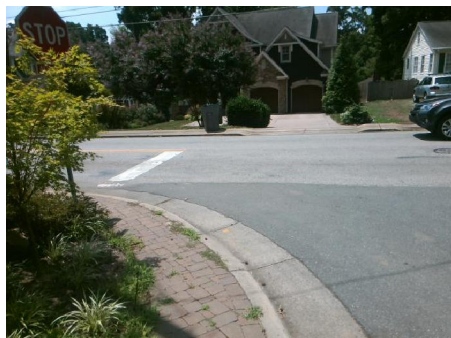
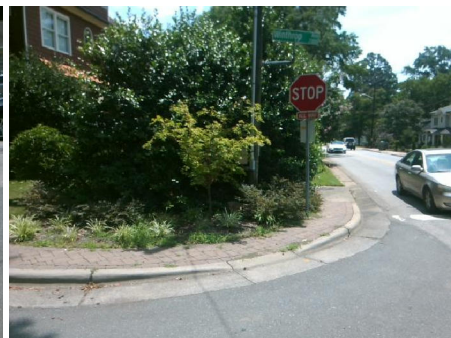
Codes/Mitigation Info/Possible Solution			Field Measurements/Component Compliance					
	Possible Solutions:		Compliance	Description	Data	Compliance	Description	Data
	Remove & Replace Curb Ramp With Two New Directional Ramps or Equivalent.		N/A	Ramp Length (in)	32.0	Yes	Ramp Slope (%)	5.2
			No	Ramp Width (in)	46.0	No	Ramp XSlope (%)	8.1
			N/A	Flare Type LT	N/A	N/A	Flare Type RT	N/A
			N/A	Flare Slope LT (%)	N/A	N/A	Flare Slope RT (%)	N/A
Surveyor Notes: N/A			N/A	Flare Traversable LT?	N/A	N/A	Flare Traversable RT?	N/A
			N/A	Landing Length (in)	N/A	N/A	DWS Provided?	N/A
			N/A	Landing Width (in)	N/A	N/A	DWS Contrast?	N/A
			N/A	Landing Slope (%)	N/A	N/A	DWS Length (in)	N/A
			N/A	Landing X Slope (%)	N/A	N/A	DWS Full Width?	N/A
PROW/ADA: Not Found, R304.5.1, R304.5.3			N/A	Landing Curb? (Y/N)	N/A	N/A	DWS Offset (in)	N/A
			N/A	Shared Landing?	N/A			
			N/A	Gutter Ponding?	N/A	N/A	Gutter Slope (%)	N/A
			N/A	Gutter Lip Ht (in)	N/A	N/A	Gutter X Slope (%)	N/A

N/A	Painted X Walk1?	No	N/A	Painted X Walk2?	No
Street 1 Name Stop Condition-Street 2 Street 2 Name Stop Condition-Street 1				X Walk 1 Direction	To W		X Walk 2 Direction	To S
			N/A	X Walk 1 Width (in)	N/A	N/A	X Walk 2 Width (in)	N/A
				X Walk 1 Slope (%)	2.0		X Walk 2 Slope (%)	1.7
				X Walk 1 X Slope (%)	0.0		X Walk 2 X Slope (%)	5.3
			N/A	Ramp inside XWalk1?	N/A	N/A	Ramp inside XWalk2?	N/A
Total Cost:		\$ 3200.00		Road Slope (%)	3.2	N/A	Clear Space?	N/A
				Road X Slope (%)	4.4	N/A	Clear Space to XWalk (in)	N/A
			N/A	Any Obstructions?	N/A	N/A	Storm Grate/Utility Hazard?	N/A
				Obstruction Type			Storm Grate/Utility Type	
					N/A			N/A
						Yes	Surface Condition? (G/P)	Good
