Access Compliance Report

Public Rights-of-Way

(Curb Ramps)

Intersection ID: 10029862	Main Street: KUYKENDALL_RD	Cross Street: N/A	Location: SE
ADA ID: 0182FBB967A7	Ramp Type: BlendTrans1	Initial Pass/Fail: Fail	Overall Compliance: No
Severity Score: 12.5			
Codes/Mitigation Info/Possible Solution		Field Measurements/Component Compliance

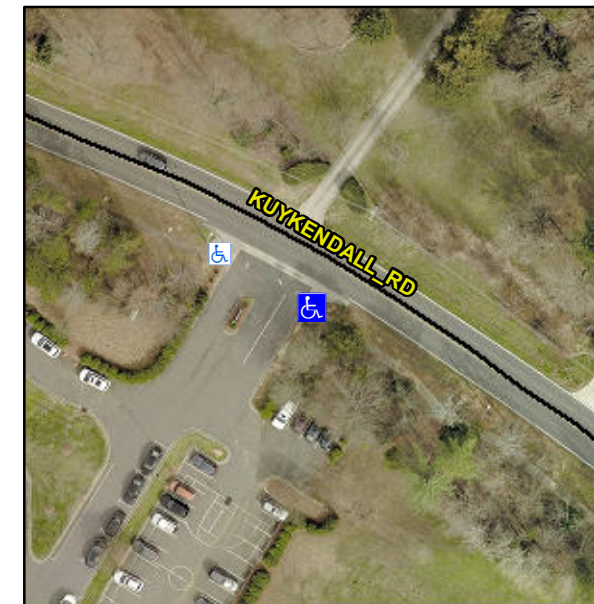
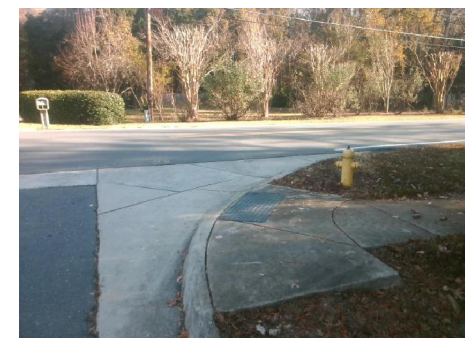
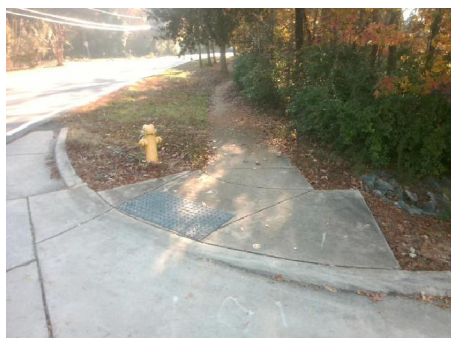
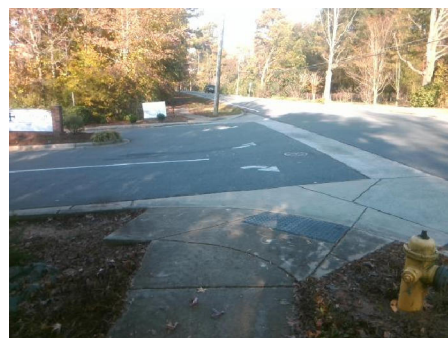
Compliance	Description	Data	Compliance	Description	Data
N/A	Ramp Length (in)	58.0	Yes	BlendTrans Slope (%)	2.7
Yes	Ramp Width (in)	48.0	No	BlendTrans XSlope (%)	6.6
N/A	Flare Type LT	N/A	N/A	Flare Type RT	N/A
N/A	Flare Slope LT (%)	N/A	N/A	Flare Slope RT (%)	N/A
N/A	Flare Traversable LT?	N/A	N/A	Flare Traversable RT?	N/A
N/A	Landing Length (in)	N/A	N/A	DWS Provided?	N/A
N/A	Landing Width (in)	N/A	N/A	DWS Contrast?	N/A
N/A	Landing Slope (%)	N/A	N/A	DWS Length (in)	N/A
N/A	Landing X Slope (%)	N/A	N/A	DWS Full Width?	N/A
N/A	Landing Curb? (Y/N)	N/A	N/A	DWS Offset (in)	N/A
N/A	Shared Landing?	N/A			
N/A	Gutter Ponding?	N/A	N/A	Gutter Slope (%)	N/A
N/A	Gutter Lip Ht (in)	N/A	N/A	Gutter X Slope (%)	N/A
N/A	Painted X Walk1?	No	N/A	Painted X Walk2?	No
	X Walk 1 Direction	To NE		X Walk 2 Direction	To NW
	X Walk 1 Width (in)	N/A		X Walk 2 Width (in)	N/A
	X Walk 1 Slope (%)	5.2		X Walk 2 Slope (%)	2.0
	X Walk 1 X Slope (%)	1.1		X Walk 2 X Slope (%)	9.3

N/A	Ramp inside XWalk1?	N/A	N/A	Ramp inside XWalk2?	N/A
	Road Slope (%)	5.8		Clear Space?	N/A
	Road X Slope (%)	3.3	N/A	Clear Space to XWalk (in)	N/A
N/A	Any Obstructions?	N/A	N/A	Storm Grate/Utility Hazard?	N/A
	Obstruction Type			Storm Grate/Utility Type	
		N/A			N/A
			Yes	Surface Condition? (G/P)	Good
			N/A	Curb Slope (%)	2.7

Possible Solutions:

Remove & Replace Curb Ramp With Two New Directional Ramps or Equivalent.

R304.5.3
