| Intersection ID: 12618 | Main Street: E_5TH_ST | Cross Street: N_CALDWELL_ST | Location: | E |
| ADA ID: 0184F06BCA18 | Ramp Type: BlendTrans1 | Initial Pass/Fail: Pass | Overall Compliance: No | Severity Score: 20 |

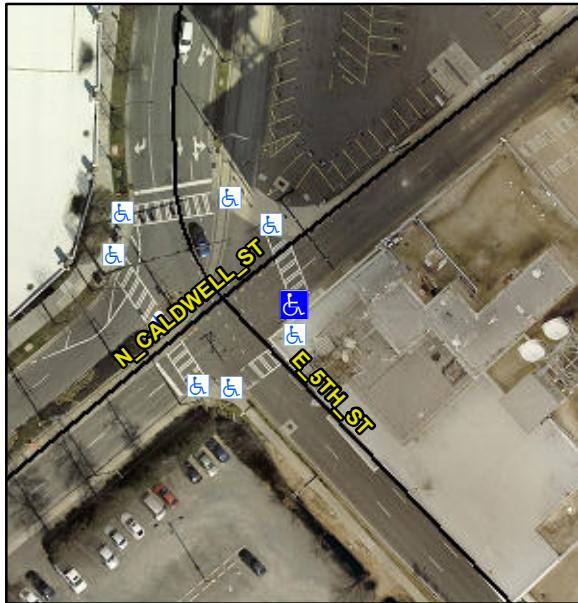
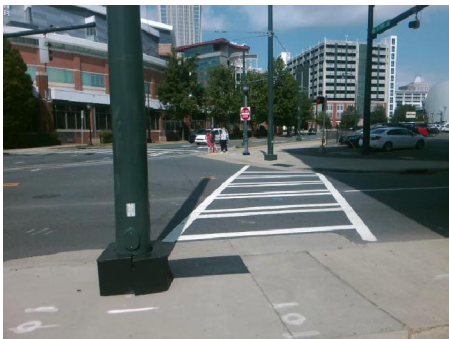
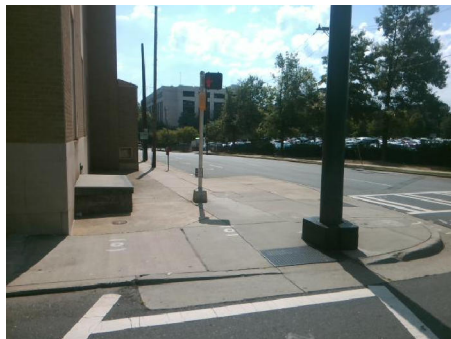
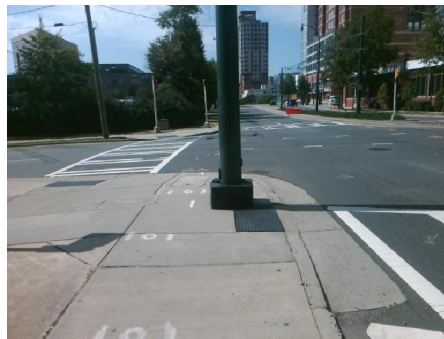
| Compliance | Description | Data | Compliance | Description | Data |
|---|---|---|---|---|---|
| No | Ramp inside XWalk1? | No | N/A | Ramp inside XWalk2? | N/A |
| No | Any Obstructions? | Yes | Yes | Storm Grate/Utility Hazard? | No |
| POWER POLE 36.0 | | | | | N/A |
| | | | No | Curb Slope (%) | 10.8 |

**Remove & Replace Curb Slope and
Extend Ramp. Restripe Crosswalk.
Relocate Obstruction.**

Not Found, R207.1, R302.3, R402.2
