# Access Compliance Report

## Public Rights-of-Way

### (Curb Ramps)

Intersection ID: 49699	Main Street: VAUGHAN_DR	Cross Street: HIGHLAND_MEADOW_RD	Location: NW
ADA ID: 0190F9776B09	Ramp Type: PerpDiag	Initial Pass/Fail: Fail	Overall Compliance: No
Severity Score: 12.5			
Codes/Mitigation Info/Possible Solution		Field Measurements/Component Compliance

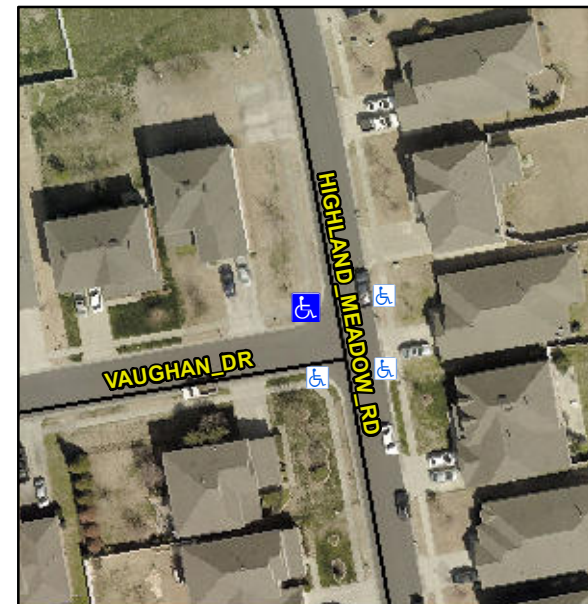
Compliance	Description	Data	Compliance	Description	Data
N/A	Ramp Length (in)	47.0	No	Ramp Slope (%)	11.5
Yes	Ramp Width (in)	48.0	Yes	Ramp XSlope (%)	0.6
N/A	Flare Type LT	N/A	N/A	Flare Type RT	N/A
N/A	Flare Slope LT (%)	N/A	N/A	Flare Slope RT (%)	N/A
N/A	Flare Traversable LT?	N/A	N/A	Flare Traversable RT?	N/A
N/A	Landing Length (in)	N/A	N/A	DWS Provided?	N/A
N/A	Landing Width (in)	N/A	N/A	DWS Contrast?	N/A
N/A	Landing Slope (%)	N/A	N/A	DWS Length (in)	N/A
N/A	Landing X Slope (%)	N/A	N/A	DWS Full Width?	N/A
N/A	Landing Curb? (Y/N)	N/A	N/A	DWS Offset (in)	N/A
N/A	Shared Landing?	N/A			
N/A	Gutter Ponding?	N/A	N/A	Gutter Slope (%)	N/A
N/A	Gutter Lip Ht (in)	N/A	N/A	Gutter X Slope (%)	N/A
N/A	Painted X Walk1?	No	N/A	Painted X Walk2?	No
	X Walk 1 Direction	To S		X Walk 2 Direction	To E
N/A	X Walk 1 Width (in)	N/A	N/A	X Walk 2 Width (in)	N/A
	X Walk 1 Slope (%)	1.9		X Walk 2 Slope (%)	2.3
	X Walk 1 X Slope (%)	0.1		X Walk 2 X Slope (%)	1.3

N/A	Ramp inside XWalk1?	N/A	N/A	Ramp inside XWalk2?	N/A
	Road Slope (%)	0.2	N/A	Clear Space?	N/A
	Road X Slope (%)	2.6	N/A	Clear Space to XWalk (in)	N/A
N/A	Any Obstructions?	N/A	N/A	Storm Grate/Utility Hazard?	N/A
	Obstruction Type			Storm Grate/Utility Type	
		N/A			N/A
			Yes	Surface Condition? (G/P)	Good

**Remove & Replace Curb Ramp With Two New Directional Ramps or Equivalent.**
