# Access Compliance Report

## Public Rights-of-Way

### (Curb Ramps)

| Intersection ID: 27422 | Main Street: BALLANTYNE COMMONS PY | Cross Street: STONEBRIAR DR | Location: SE |

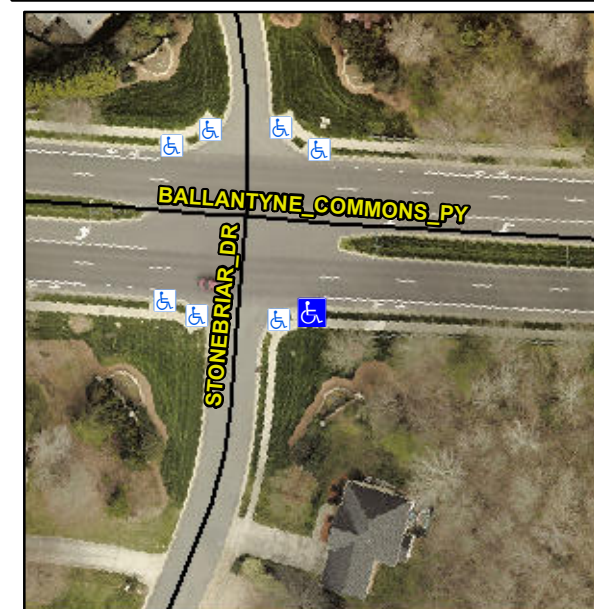
| ADA ID: 01916DCAA89C | Ramp Type: Perp | Initial Pass/Fail: Fail | Overall Compliance: No |
| Severity Score: 12.5 | | | |

**Not Found, R304.2.2**

| Compliance | Description | Data | Compliance | Description | Data |
|---|---|---|---|---|---|
| N/A | Ramp Length (in) | 64.0 | No | Ramp Slope (%) | 9.3 |

**Remove & Replace Entire Ramp.**

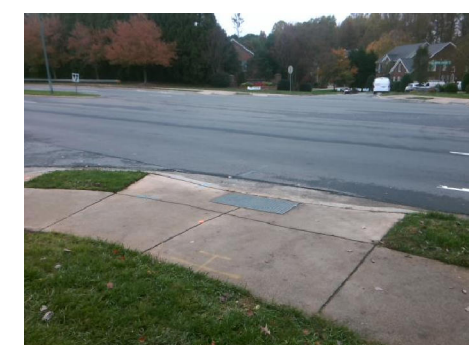
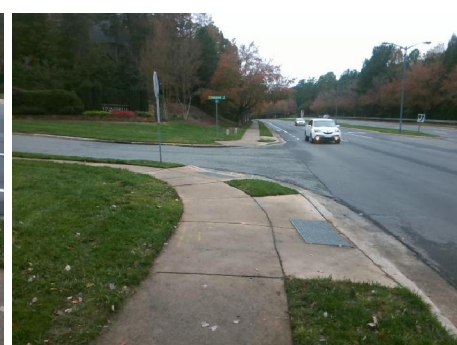
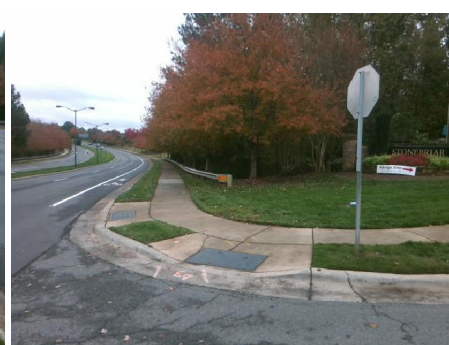
| Compliance | Description | Data | Compliance | Description | Data |
|---|---|---|---|---|---|
| Yes | Ramp Width (in) | 48.0 | Yes | Ramp XSlope (%) | 1.1 |
| | | | Yes | Surface Condition? (G/P) | Good |
