Access Compliance Report

Public Rights-of-Way

(Curb Ramps)

Intersection ID: 28315	Main Street: CARMODY_CT	Cross Street: ZACKERY_AV	Location: NE
ADA ID: 0192BF0FCD39	Ramp Type: PerpDiag	Initial Pass/Fail: Fail	Overall Compliance: No
		Severity Score: 1.25

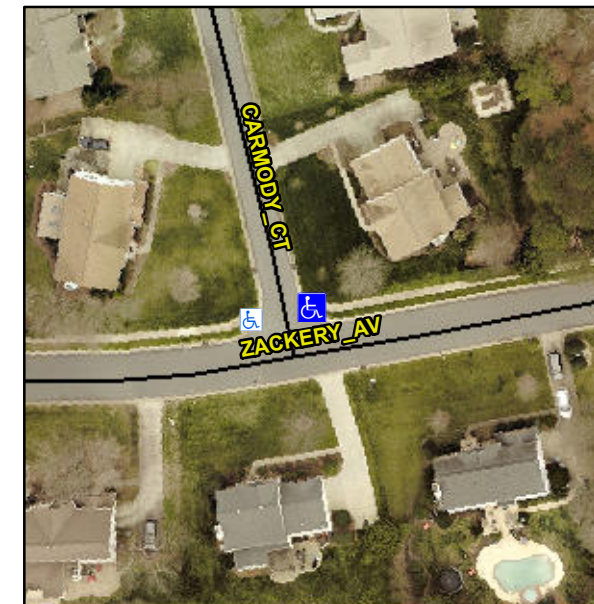
Not Found, R304.5.3

Compliance	Description	Data	Compliance	Description	Data
N/A	Ramp Length (in)	48.0	Yes	Ramp Slope (%)	5.1
Yes	Ramp Width (in)	50.0	No	Ramp XSlope (%)	4.5
N/A	Flare Type LT	N/A	N/A	Flare Type RT	N/A
N/A	Flare Slope LT (%)	N/A	N/A	Flare Slope RT (%)	N/A
N/A	Flare Traversable LT?	N/A	N/A	Flare Traversable RT?	N/A
N/A	Landing Length (in)	N/A	N/A	DWS Provided?	N/A
N/A	Landing Width (in)	N/A	N/A	DWS Contrast?	N/A
N/A	Landing Slope (%)	N/A	N/A	DWS Length (in)	N/A
N/A	Landing X Slope (%)	N/A	N/A	DWS Full Width?	N/A
N/A	Landing Curb? (Y/N)	N/A	N/A	DWS Offset (in)	N/A
N/A	Shared Landing?	N/A			
N/A	Gutter Ponding?	N/A	N/A	Gutter Slope (%)	N/A
N/A	Gutter Lip Ht (in)	N/A	N/A	Gutter X Slope (%)	N/A
N/A	Painted X Walk1?	No	N/A	Painted X Walk2?	No
	X Walk 1 Direction	To W		X Walk 2 Direction	To S
N/A	X Walk 1 Width (in)	N/A	N/A	X Walk 2 Width (in)	N/A
	X Walk 1 Slope (%)	3.1		X Walk 2 Slope (%)	3.0
	X Walk 1 X Slope (%)	1.7		X Walk 2 X Slope (%)	2.8

N/A	Ramp inside XWalk1?	N/A	N/A	Ramp inside XWalk2?	N/A
	Road Slope (%)	3.3	N/A	Clear Space?	N/A
	Road X Slope (%)	3.4	N/A	Clear Space to XWalk (in)	N/A
N/A	Any Obstructions?	N/A	N/A	Storm Grate/Utility Hazard?	N/A
	Obstruction Type			Storm Grate/Utility Type	
		N/A			N/A
		Yes		Surface Condition? (G/P)	Good

Remove & Replace Curb Ramp With Two New Directional Ramps or Equivalent.

Total Cost: \$ 3200.00
