Access Compliance Report

Public Rights-of-Way

(Curb Ramps)

Intersection ID: 50589	Main Street: BENDING_BRANCH_RD	Cross Street: GREEN_GRASS_RD	Location: W
ADA ID: 01A024D9978E	Ramp Type: Perp	Initial Pass/Fail: Fail	Overall Compliance: No
Severity Score: 22.5			
Codes/Mitigation Info/Possible Solution		Field Measurements/Component Compliance

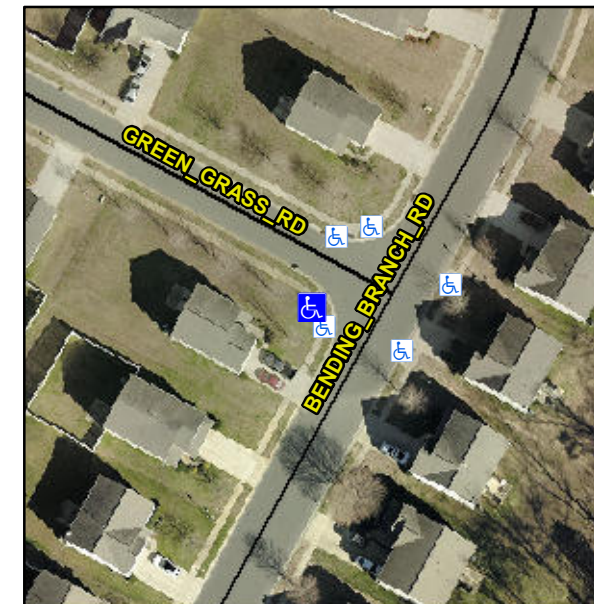
Not Found, R304.5.1, R304.2.2, R304.5.3

Compliance	Description	Data	Compliance	Description	Data
N/A	Ramp Length (in)	49.0	No	Ramp Slope (%)	9.0
No	Ramp Width (in)	47.5	No	Ramp XSlope (%)	3.9
N/A	Flare Type LT	N/A	N/A	Flare Type RT	N/A
N/A	Flare Slope LT (%)	N/A	N/A	Flare Slope RT (%)	N/A
N/A	Flare Traversable LT?	N/A	N/A	Flare Traversable RT?	N/A
N/A	Landing Length (in)	N/A	N/A	DWS Provided?	N/A
N/A	Landing Width (in)	N/A	N/A	DWS Contrast?	N/A
N/A	Landing Slope (%)	N/A	N/A	DWS Length (in)	N/A
N/A	Landing X Slope (%)	N/A	N/A	DWS Full Width?	N/A
N/A	Landing Curb? (Y/N)	N/A	N/A	DWS Offset (in)	N/A
N/A	Shared Landing?	N/A			
N/A	Gutter Ponding?	N/A	N/A	Gutter Slope (%)	N/A
N/A	Gutter Lip Ht (in)	N/A	N/A	Gutter X Slope (%)	N/A
N/A	Painted X Walk1?	No	N/A	Painted X Walk2?	N/A
	X Walk 1 Direction	To NE		X Walk 2 Direction	N/A
N/A	X Walk 1 Width (in)	N/A	N/A	X Walk 2 Width (in)	N/A
	X Walk 1 Slope (%)	1.3		X Walk 2 Slope (%)	N/A
	X Walk 1 X Slope (%)	3.5		X Walk 2 X Slope (%)	N/A

Possible Solutions:

Remove & Replace Entire Ramp.

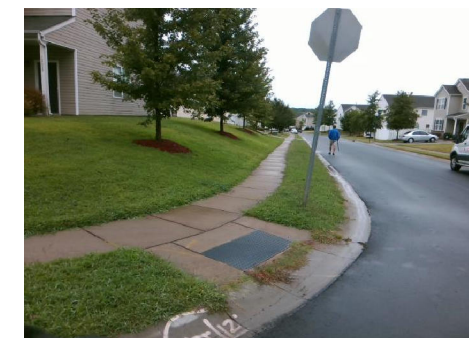
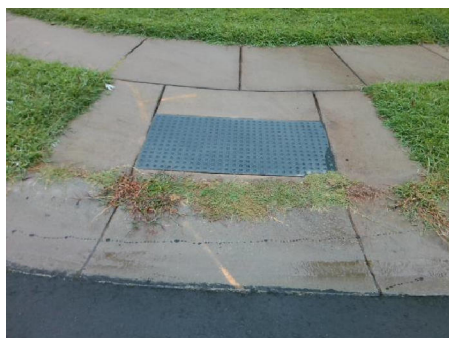
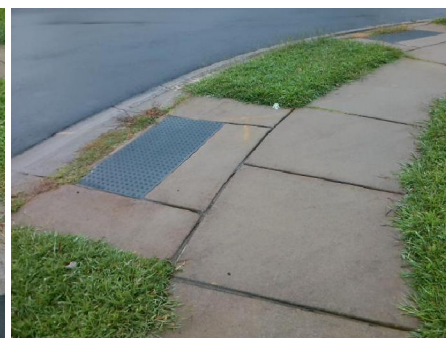
N/A	Ramp inside XWalk1?	N/A	N/A	Ramp inside XWalk2?	N/A
	Road Slope (%)	N/A	N/A	Clear Space?	N/A
	Road X Slope (%)	N/A	N/A	Clear Space to XWalk (in)	N/A
N/A	Any Obstructions?	N/A	N/A	Storm Grate/Utility Hazard?	N/A
	Obstruction Type			Storm Grate/Utility Type	
		N/A			N/A
			Yes	Surface Condition? (G/P)	Good
