# Access Compliance Report

## Public Rights-of-Way

### (Curb Ramps)

Intersection ID: 4382	Main Street: NEWCHURCH_CR	Cross Street: SYMPHONY_WOODS_DR	Location:	N
ADA ID: 01A1FAE2F815	Ramp Type: Perp	Initial Pass/Fail: Fail	Overall Compliance: No	Severity Score: 58.75
Codes/Mitigation Info/Possible Solution		Field Measurements/Component Compliance

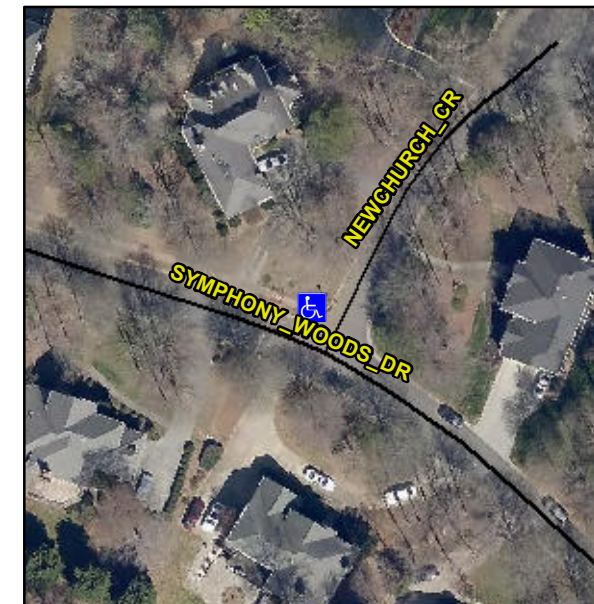
**Not Found, R304.5.1, R304.2.2, R304.5.3**

Compliance	Description	Data	Compliance	Description	Data
N/A	Ramp Length (in)	95.0	No	Ramp Slope (%)	12.6
No	Ramp Width (in)	46.5	No	Ramp XSlope (%)	9.1
N/A	Flare Type LT	N/A	N/A	Flare Type RT	N/A
N/A	Flare Slope LT (%)	N/A	N/A	Flare Slope RT (%)	N/A
N/A	Flare Traversable LT?	N/A	N/A	Flare Traversable RT?	N/A
N/A	Landing Length (in)	N/A	N/A	DWS Provided?	N/A
N/A	Landing Width (in)	N/A	N/A	DWS Contrast?	N/A
N/A	Landing Slope (%)	N/A	N/A	DWS Length (in)	N/A
N/A	Landing X Slope (%)	N/A	N/A	DWS Full Width?	N/A
N/A	Landing Curb? (Y/N)	N/A	N/A	DWS Offset (in)	N/A
N/A	Shared Landing?	N/A			
N/A	Gutter Ponding?	N/A	N/A	Gutter Slope (%)	N/A
N/A	Gutter Lip Ht (in)	N/A	N/A	Gutter X Slope (%)	N/A
N/A	Painted X Walk1?	No	N/A	Painted X Walk2?	N/A
	X Walk 1 Direction	To SW		X Walk 2 Direction	N/A
N/A	X Walk 1 Width (in)	N/A	N/A	X Walk 2 Width (in)	N/A
	X Walk 1 Slope (%)	3.0		X Walk 2 Slope (%)	N/A
	X Walk 1 X Slope (%)	5.3		X Walk 2 X Slope (%)	N/A

N/A	Ramp inside XWalk1?	N/A	N/A	Ramp inside XWalk2?	N/A
	Road Slope (%)	N/A	N/A	Clear Space?	N/A
	Road X Slope (%)	N/A	N/A	Clear Space to XWalk (in)	N/A
N/A	Any Obstructions?	N/A	N/A	Storm Grate/Utility Hazard?	N/A
	Obstruction Type			Storm Grate/Utility Type	
		N/A			N/A
			Yes	Surface Condition? (G/P)	Good

Possible Solutions:

**Remove & Replace Entire Ramp.**
