# Access Compliance Report

## Public Rights-of-Way

### (Curb Ramps)

Intersection ID: 43358	Main Street: PROSPERITY COMMONS DR	Cross Street: ROCKY FORD CLUB RD	Location: NW
ADA ID: 01A62C7CAFE6	Ramp Type: Perp	Initial Pass/Fail: Pass	Overall Compliance: No
Severity Score: 1.25			
Codes/Mitigation Info/Possible Solution		Field Measurements/Component Compliance

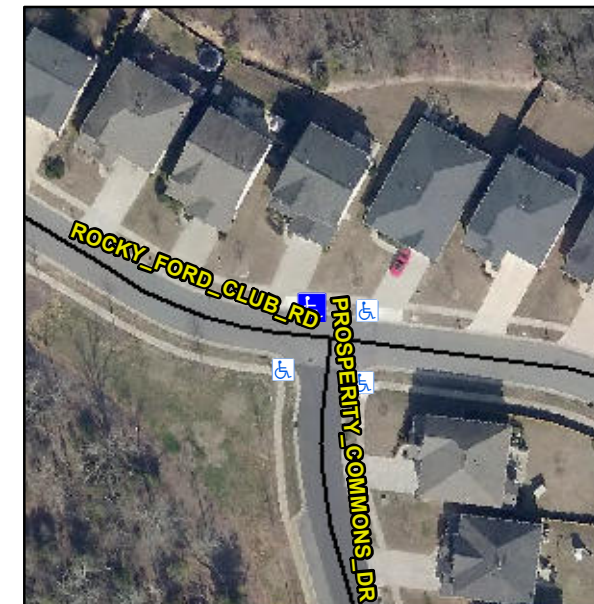
**Not Found, R304.5.1**

Compliance	Description	Data	Compliance	Description	Data
N/A	Ramp Length (in)	70.0	Yes	Ramp Slope (%)	6.4
No	Ramp Width (in)	47.5	Yes	Ramp XSlope (%)	1.4
N/A	Flare Type LT	Sloped	N/A	Flare Type RT	N/A
N/A	Flare Slope LT (%)	8.0	Yes	Flare Slope RT (%)	1.2
N/A	Flare Traversable LT?	Yes	N/A	Flare Traversable RT?	Yes
Yes	Landing Length (in)	48.0	Yes	DWS Provided?	Yes
Yes	Landing Width (in)	48.0	Yes	DWS Contrast?	Yes
Yes	Landing Slope (%)	1.9	Yes	DWS Length (in)	24.0
Yes	Landing X Slope (%)	2.0	Yes	DWS Full Width?	Yes
N/A	Landing Curb? (Y/N)	No	Yes	DWS Offset (in)	1.5
N/A	Shared Landing?	Yes			
Yes	Gutter Ponding?	No	Yes	Gutter Slope (%)	2.7
Yes	Gutter Lip Ht (in)	0.0	Yes	Gutter X Slope (%)	1.1
N/A	Painted X Walk1?	No	N/A	Painted X Walk2?	N/A
	X Walk 1 Direction	To SW		X Walk 2 Direction	N/A
N/A	X Walk 1 Width (in)	N/A	N/A	X Walk 2 Width (in)	N/A
	X Walk 1 Slope (%)	1.1		X Walk 2 Slope (%)	N/A
	X Walk 1 X Slope (%)	2.7		X Walk 2 X Slope (%)	N/A

N/A	Ramp inside XWalk1?	N/A	N/A	Ramp inside XWalk2?	N/A
	Road Slope (%)	N/A	N/A	Clear Space?	Yes
	Road X Slope (%)	N/A	N/A	Clear Space to XWalk (in)	N/A
Yes	Any Obstructions?	No	Yes	Storm Grate/Utility Hazard?	No
	Obstruction Type			Storm Grate/Utility Type	
		N/A			N/A
			Yes	Surface Condition? (G/P)	Good

Possible Solutions:

**Remove & Replace Entire Ramp.**

Total Cost: \$ 1850.00
