Access Compliance Report

Public Rights-of-Way

(Curb Ramps)

Intersection ID: 14792	Main Street: RANDOLPH_RD	Cross Street: VAN_NESS_ST	Location: NE
ADA ID: 01AAC32CF050	Ramp Type: Perp	Initial Pass/Fail: Fail	Overall Compliance: No
Severity Score: 1.25			
Codes/Mitigation Info/Possible Solution		Field Measurements/Component Compliance

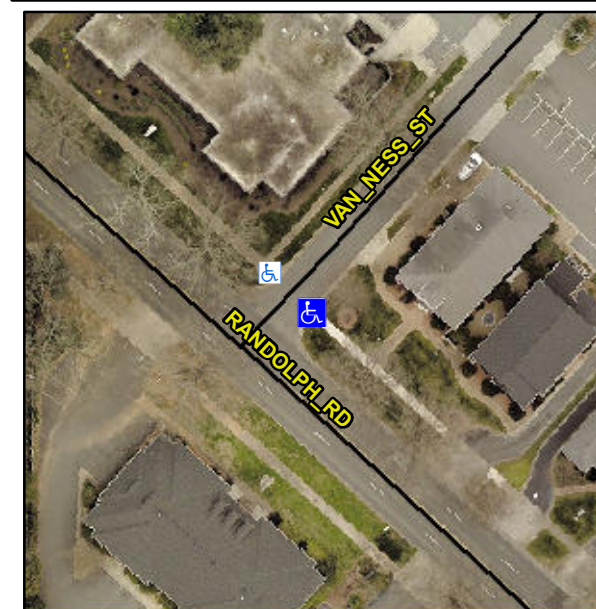
Not Found, R304.5.3

Compliance	Description	Data	Compliance	Description	Data
N/A	Ramp Length (in)	84.0	Yes	Ramp Slope (%)	6.6
Yes	Ramp Width (in)	48.0	No	Ramp XSlope (%)	2.8
N/A	Flare Type LT	N/A	N/A	Flare Type RT	N/A
N/A	Flare Slope LT (%)	N/A	N/A	Flare Slope RT (%)	N/A
N/A	Flare Traversable LT?	N/A	N/A	Flare Traversable RT?	N/A
N/A	Landing Length (in)	N/A	N/A	DWS Provided?	N/A
N/A	Landing Width (in)	N/A	N/A	DWS Contrast?	N/A
N/A	Landing Slope (%)	N/A	N/A	DWS Length (in)	N/A
N/A	Landing X Slope (%)	N/A	N/A	DWS Full Width?	N/A
N/A	Landing Curb? (Y/N)	N/A	N/A	DWS Offset (in)	N/A
N/A	Shared Landing?	N/A			
N/A	Gutter Ponding?	N/A	N/A	Gutter Slope (%)	N/A
N/A	Gutter Lip Ht (in)	N/A	N/A	Gutter X Slope (%)	N/A
N/A	Painted X Walk1?	No	N/A	Painted X Walk2?	N/A
	X Walk 1 Direction	To NW		X Walk 2 Direction	N/A
N/A	X Walk 1 Width (in)	N/A	N/A	X Walk 2 Width (in)	N/A
	X Walk 1 Slope (%)	6.6		X Walk 2 Slope (%)	N/A
	X Walk 1 X Slope (%)	2.5		X Walk 2 X Slope (%)	N/A

N/A	Ramp inside XWalk1?	N/A	N/A	Ramp inside XWalk2?	N/A
	Road Slope (%)	N/A	N/A	Clear Space?	N/A
	Road X Slope (%)	N/A	N/A	Clear Space to XWalk (in)	N/A
N/A	Any Obstructions?	N/A	N/A	Storm Grate/Utility Hazard?	N/A
	Obstruction Type			Storm Grate/Utility Type	
		N/A			N/A
		Yes		Surface Condition? (G/P)	Good

Remove & Replace Entire Ramp.
