Access Compliance Report

Public Rights-of-Way

(Curb Ramps)

Intersection ID: 10033675	Main Street: ORCHARD_LAKE_DR	Cross Street: N/A	Location:	N
ADA ID: 01AB086AE AFC	Ramp Type: BlendTrans1	Initial Pass/Fail: Fail	Overall Compliance: No	Severity Score: 1.25
Codes/Mitigation Info/Possible Solution		Field Measurements/Component Compliance

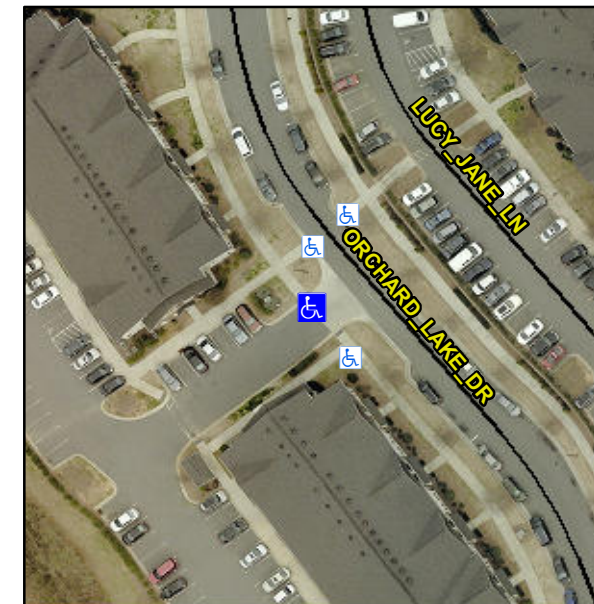
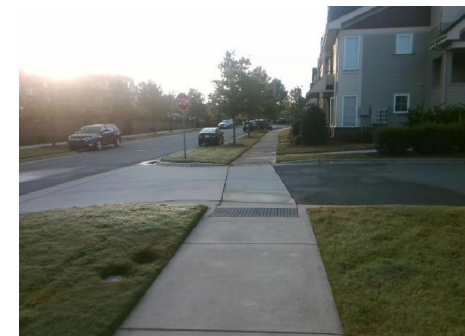
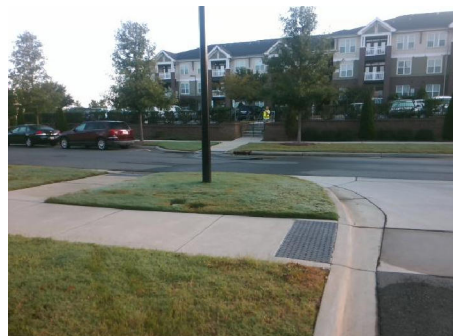
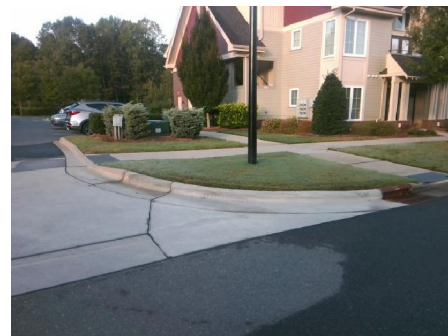
R304.5.3

Compliance	Description	Data	Compliance	Description	Data
N/A	Ramp Length (in)	72.0	Yes	BlendTrans Slope (%)	1.2
Yes	Ramp Width (in)	72.0	No	BlendTrans XSlope (%)	2.3
N/A	Flare Type LT	N/A	N/A	Flare Type RT	N/A
N/A	Flare Slope LT (%)	N/A	N/A	Flare Slope RT (%)	N/A
N/A	Flare Traversable LT?	N/A	N/A	Flare Traversable RT?	N/A
N/A	Landing Length (in)	N/A	N/A	DWS Provided?	N/A
N/A	Landing Width (in)	N/A	N/A	DWS Contrast?	N/A
N/A	Landing Slope (%)	N/A	N/A	DWS Length (in)	N/A
N/A	Landing X Slope (%)	N/A	N/A	DWS Full Width?	N/A
N/A	Landing Curb? (Y/N)	N/A	N/A	DWS Offset (in)	N/A
N/A	Shared Landing?	N/A			
N/A	Gutter Ponding?	N/A	N/A	Gutter Slope (%)	N/A
N/A	Gutter Lip Ht (in)	N/A	N/A	Gutter X Slope (%)	N/A
N/A	Painted X Walk1?	No	N/A	Painted X Walk2?	N/A
	X Walk 1 Direction	To SE		X Walk 2 Direction	N/A
	X Walk 1 Width (in)	N/A		X Walk 2 Width (in)	N/A
	X Walk 1 Slope (%)	1.8		X Walk 2 Slope (%)	N/A
	X Walk 1 X Slope (%)	1.1		X Walk 2 X Slope (%)	N/A

N/A	Ramp inside XWalk1?	N/A	N/A	Ramp inside XWalk2?	N/A
	Road Slope (%)	1.1		Clear Space?	N/A
	Road X Slope (%)	1.8	N/A	Clear Space to XWalk (in)	N/A
N/A	Any Obstructions?	N/A	N/A	Storm Grate/Utility Hazard?	N/A
	Obstruction Type			Storm Grate/Utility Type	
		N/A			N/A
			Yes	Surface Condition? (G/P)	Good
			N/A	Curb Slope (%)	1.6

Remove & Replace Curb Ramp With Two New Directional Ramps or Equivalent.
