# Access Compliance Report

## Public Rights-of-Way

### (Curb Ramps)

Intersection ID: 45980	Main Street: LAUREL_VALLEY_RD	Cross Street: SHOPTON_RD	Location: SW
ADA ID: 01B3D398E4AA	Ramp Type: PerpDiag	Initial Pass/Fail: Fail	Overall Compliance: No
			Severity Score: 46.25

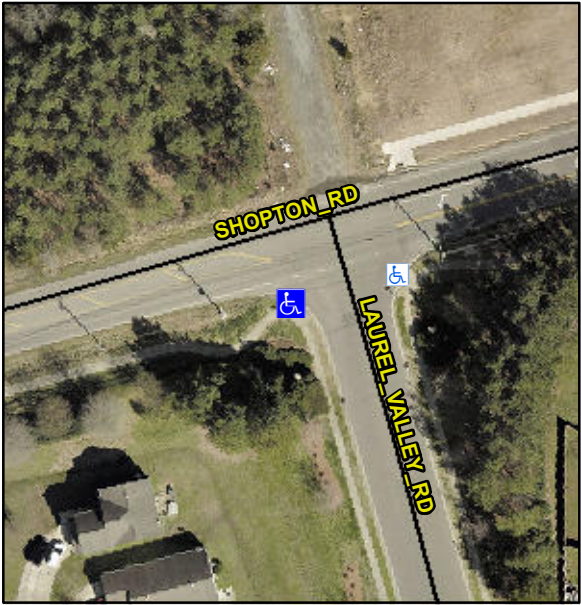
<p>Street 1 Name LAUREL VALLEY RD</p> <p>Stop Condition-Street 2 StopSign</p> <p>Street 2 Name SHOPTON RD</p> <p>Stop Condition-Street 1 None</p>	<p>Possible Solutions:</p> <p><b>Remove &amp; Replace Curb Ramp With Two New Directional Ramps or Equivalent.</b></p> <p>Surveyor Notes:</p> <p><b>N/A</b></p> <p>PROW/ADA:</p> <p><b>Not Found, R304.5.1, R304.2.2, R304.5.3</b></p> <p>Total Cost: \$ 3200.00</p>	Compliance	Description	Data	
		N/A	Ramp Length (in)	47.0	No
		No	Ramp Width (in)	42.0	No
		N/A	Flare Type LT	N/A	N/A
		N/A	Flare Slope LT (%)	N/A	N/A
		N/A	Flare Traversable LT?	N/A	N/A
		N/A	Landing Length (in)	N/A	N/A
		N/A	Landing Width (in)	N/A	N/A
		N/A	Landing Slope (%)	N/A	N/A
		N/A	Landing X Slope (%)	N/A	N/A
		N/A	Landing Curb? (Y/N)	N/A	N/A
		N/A	Shared Landing?	N/A	
		N/A	Gutter Ponding?	N/A	N/A
		N/A	Gutter Lip Ht (in)	N/A	N/A

N/A	Painted X Walk1?	No	N/A
			X Walk 1 Direction	To E	
		N/A	X Walk 1 Width (in)	N/A	N/A
			X Walk 1 Slope (%)	7.8	
			X Walk 1 X Slope (%)	4.8	
		N/A	Ramp inside XWalk1?	N/A	N/A
			Road Slope (%)	6.7	N/A
			Road X Slope (%)	5.6	N/A
		N/A	Any Obstructions?	N/A	N/A
			Obstruction Type		
				N/A	N/A
				Yes	Surface Condition? (G/P) Good
