# Access Compliance Report

## Public Rights-of-Way

### (Curb Ramps)

Intersection ID: 15818	Main Street: CHEROKEE_PL	Cross Street: HEMPSTEAD_PL	Location: NW
ADA ID: 01B9214450A5	Ramp Type: PerpDiag	Initial Pass/Fail: Fail	Overall Compliance: No
Severity Score: 46.25			
Codes/Mitigation Info/Possible Solution		Field Measurements/Component Compliance

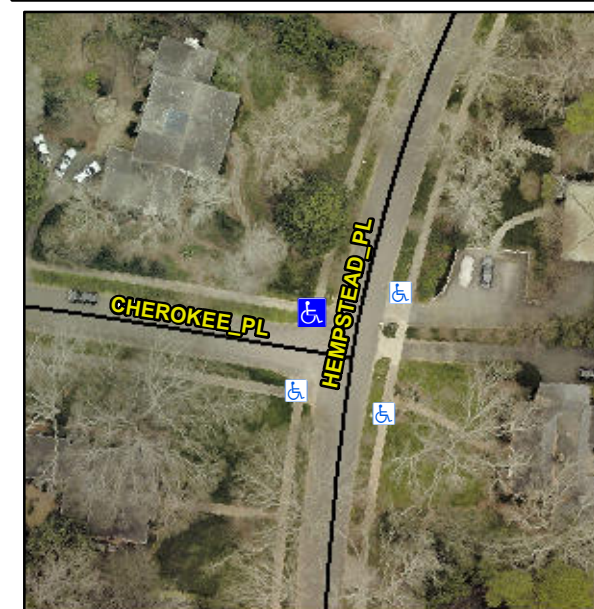
**Not Found, R304.5.1, R304.2.2, R304.5.3**

Compliance	Description	Data	Compliance	Description	Data
N/A	Ramp Length (in)	35.0	No	Ramp Slope (%)	9.3
No	Ramp Width (in)	41.0	No	Ramp XSlope (%)	11.4
N/A	Flare Type LT	N/A	N/A	Flare Type RT	N/A
N/A	Flare Slope LT (%)	N/A	N/A	Flare Slope RT (%)	N/A
N/A	Flare Traversable LT?	N/A	N/A	Flare Traversable RT?	N/A
N/A	Landing Length (in)	N/A	N/A	DWS Provided?	N/A
N/A	Landing Width (in)	N/A	N/A	DWS Contrast?	N/A
N/A	Landing Slope (%)	N/A	N/A	DWS Length (in)	N/A
N/A	Landing X Slope (%)	N/A	N/A	DWS Full Width?	N/A
N/A	Landing Curb? (Y/N)	N/A	N/A	DWS Offset (in)	N/A
N/A	Shared Landing?	N/A			
N/A	Gutter Ponding?	Yes	N/A	Gutter Slope (%)	N/A
N/A	Gutter Lip Ht (in)	N/A	N/A	Gutter X Slope (%)	N/A
N/A	Painted X Walk1?	No	N/A	Painted X Walk2?	No
	X Walk 1 Direction	To SW		X Walk 2 Direction	To E
N/A	X Walk 1 Width (in)	N/A	N/A	X Walk 2 Width (in)	N/A
	X Walk 1 Slope (%)	13.7		X Walk 2 Slope (%)	0.3
	X Walk 1 X Slope (%)	2.1		X Walk 2 X Slope (%)	10.5

N/A	Ramp inside XWalk1?	N/A	N/A	Ramp inside XWalk2?	N/A
	Road Slope (%)	8.0	N/A	Clear Space?	N/A
	Road X Slope (%)	6.5	N/A	Clear Space to XWalk (in)	N/A
N/A	Any Obstructions?	N/A	N/A	Storm Grate/Utility Hazard?	N/A
	Obstruction Type			Storm Grate/Utility Type	
		N/A			N/A
		Yes		Surface Condition? (G/P)	Good

**Remove & Replace Curb Ramp With Two New Directional Ramps or Equivalent.**
