# Access Compliance Report

## Public Rights-of-Way

### (Curb Ramps)

Intersection ID: 17504	Main Street: CORINTHIAN_PL	Cross Street: WALKER_RD	Location: NE
ADA ID: 01CB4FB632FC	Ramp Type: PerpDiag	Initial Pass/Fail: Fail	Overall Compliance: No
Codes/Mitigation Info/Possible Solution		Field Measurements/Component Compliance

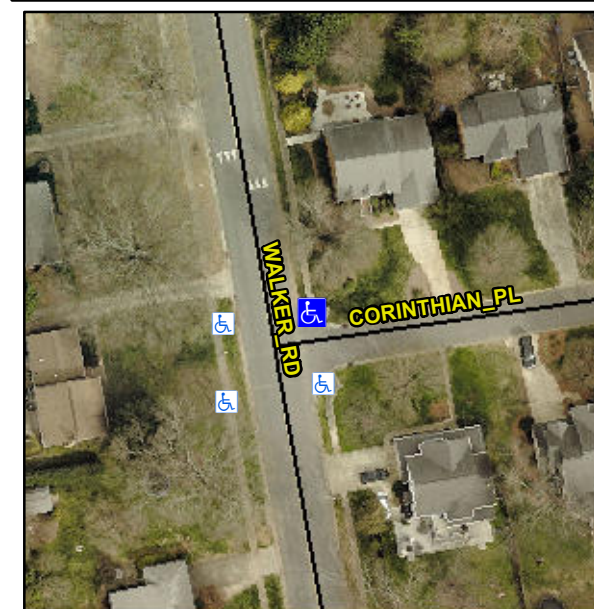
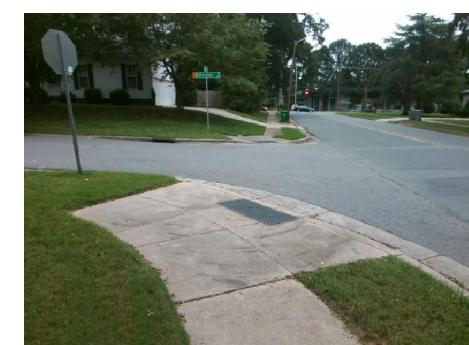
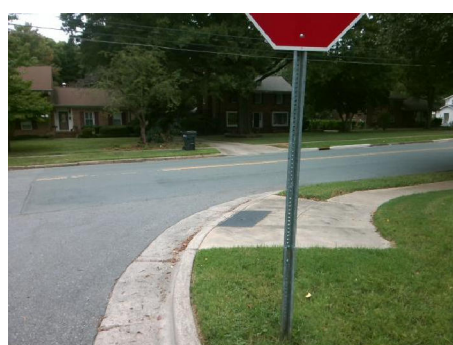
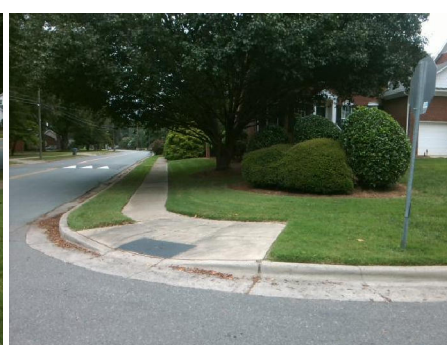
**Not Found, R304.5.1, R304.2.2, R304.5.3**

Compliance	Description	Data	Compliance	Description	Data
N/A	Ramp Length (in)	48.0	No	Ramp Slope (%)	9.2
No	Ramp Width (in)	30.0	No	Ramp XSlope (%)	4.5
N/A	Flare Type LT	N/A	N/A	Flare Type RT	N/A
N/A	Flare Slope LT (%)	N/A	N/A	Flare Slope RT (%)	N/A
N/A	Flare Traversable LT?	N/A	N/A	Flare Traversable RT?	N/A
N/A	Landing Length (in)	N/A	N/A	DWS Provided?	N/A
N/A	Landing Width (in)	N/A	N/A	DWS Contrast?	N/A
N/A	Landing Slope (%)	N/A	N/A	DWS Length (in)	N/A
N/A	Landing X Slope (%)	N/A	N/A	DWS Full Width?	N/A
N/A	Landing Curb? (Y/N)	N/A	N/A	DWS Offset (in)	N/A
N/A	Shared Landing?	N/A			
N/A	Gutter Ponding?	N/A	N/A	Gutter Slope (%)	N/A
N/A	Gutter Lip Ht (in)	N/A	N/A	Gutter X Slope (%)	N/A
N/A	Painted X Walk1?	No	N/A	Painted X Walk2?	No
	X Walk 1 Direction	To W		X Walk 2 Direction	To S
N/A	X Walk 1 Width (in)	N/A	N/A	X Walk 2 Width (in)	N/A
	X Walk 1 Slope (%)	7.6		X Walk 2 Slope (%)	2.3
	X Walk 1 X Slope (%)	2.8		X Walk 2 X Slope (%)	5.1

N/A	Ramp inside XWalk1?	N/A	N/A	Ramp inside XWalk2?	N/A
	Road Slope (%)	2.2	N/A	Clear Space?	N/A
	Road X Slope (%)	6.9	N/A	Clear Space to XWalk (in)	N/A
N/A	Any Obstructions?	N/A	N/A	Storm Grate/Utility Hazard?	N/A
	Obstruction Type			Storm Grate/Utility Type	
		N/A			N/A
			Yes	Surface Condition? (G/P)	Good

**Remove & Replace Curb Ramp With Two New Directional Ramps or Equivalent.**
