Access Compliance Report

Public Rights-of-Way

(Curb Ramps)

Intersection ID: 28076	Main Street: ALEXANDER MARTIN AV	Cross Street: REA RD	Location: W
ADA ID: 01D5D3EC236B	Ramp Type: Perp	Initial Pass/Fail: Fail	Overall Compliance: No
Severity Score: 33.75			
Codes/Mitigation Info/Possible Solution		Field Measurements/Component Compliance

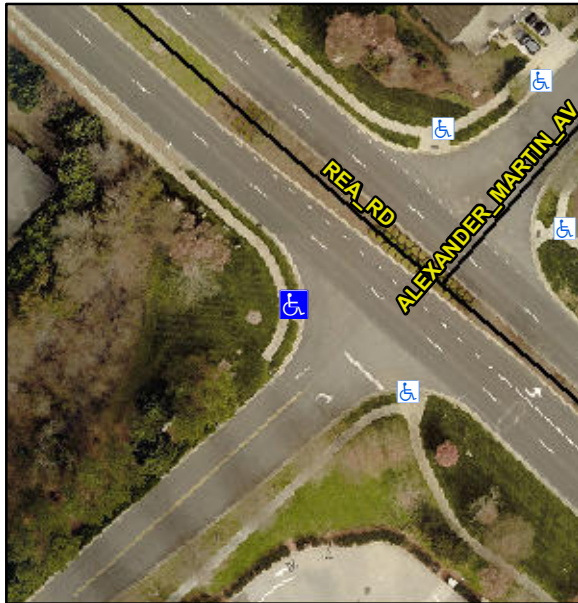
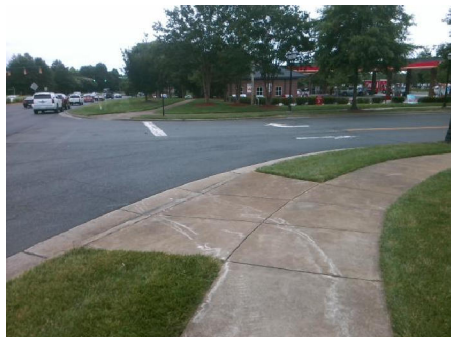
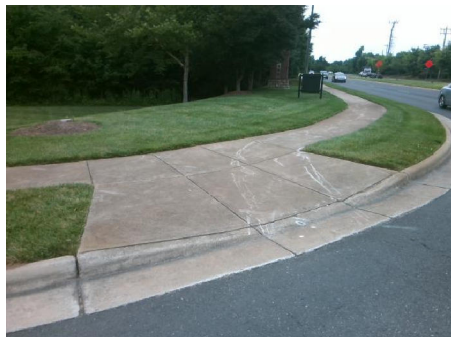
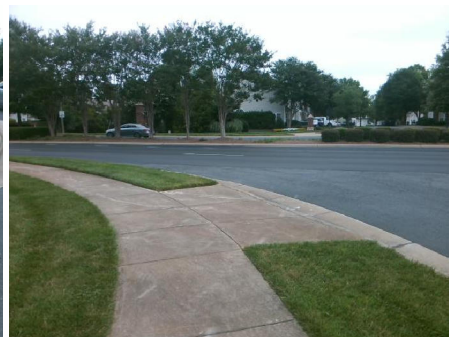
Not Found, R304.5.1, R304.2.2, R304.5.3

Compliance	Description	Data	Compliance	Description	Data
N/A	Ramp Length (in)	72.0	No	Ramp Slope (%)	9.0
No	Ramp Width (in)	46.0	No	Ramp XSlope (%)	5.4
N/A	Flare Type LT	N/A	N/A	Flare Type RT	N/A
N/A	Flare Slope LT (%)	N/A	N/A	Flare Slope RT (%)	N/A
N/A	Flare Traversable LT?	N/A	N/A	Flare Traversable RT?	N/A
N/A	Landing Length (in)	N/A	N/A	DWS Provided?	N/A
N/A	Landing Width (in)	N/A	N/A	DWS Contrast?	N/A
N/A	Landing Slope (%)	N/A	N/A	DWS Length (in)	N/A
N/A	Landing X Slope (%)	N/A	N/A	DWS Full Width?	N/A
N/A	Landing Curb? (Y/N)	N/A	N/A	DWS Offset (in)	N/A
N/A	Shared Landing?	N/A			
N/A	Gutter Ponding?	N/A	N/A	Gutter Slope (%)	N/A
N/A	Gutter Lip Ht (in)	N/A	N/A	Gutter X Slope (%)	N/A
N/A	Painted X Walk1?	No	N/A	Painted X Walk2?	N/A
	X Walk 1 Direction	To SE		X Walk 2 Direction	N/A
N/A	X Walk 1 Width (in)	N/A	N/A	X Walk 2 Width (in)	N/A
	X Walk 1 Slope (%)	0.5		X Walk 2 Slope (%)	N/A
	X Walk 1 X Slope (%)	0.4		X Walk 2 X Slope (%)	N/A

N/A	Ramp inside XWalk1?	N/A	N/A	Ramp inside XWalk2?	N/A
	Road Slope (%)	N/A	N/A	Clear Space?	N/A
	Road X Slope (%)	N/A	N/A	Clear Space to XWalk (in)	N/A
N/A	Any Obstructions?	N/A	N/A	Storm Grate/Utility Hazard?	N/A
	Obstruction Type			Storm Grate/Utility Type	
		N/A			N/A
			Yes	Surface Condition? (G/P)	Good

Remove & Replace Entire Ramp.
