# Access Compliance Report

## Public Rights-of-Way

### (Curb Ramps)

Intersection ID: 23679	Main Street: BRANDON_FOREST_DR	Cross Street: TIERGARTEN_LN	Location: SE
ADA ID: 01E8C8B57C6E	Ramp Type: PerpDiag	Initial Pass/Fail: Fail	Overall Compliance: No
			Severity Score: 26.25

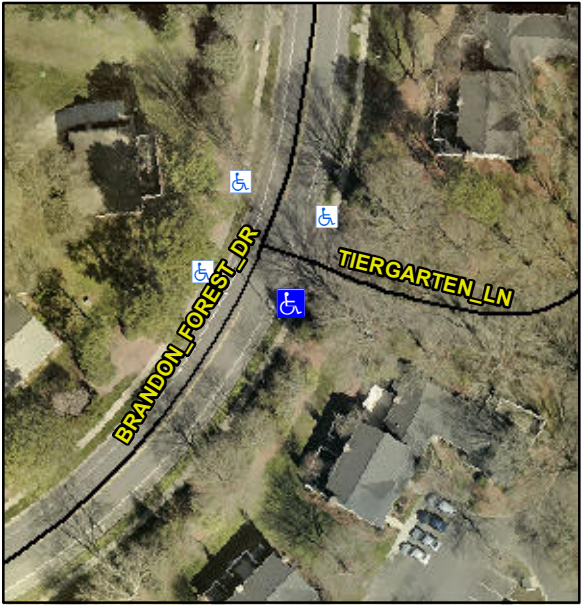
Possible Solutions:		<b>Compliance</b>	<b>Description</b>	<b>Data</b>
	Remove & Replace Curb Ramp With Two New Directional Ramps or Equivalent.		N/A	Ramp Length (in)	53.0
			Yes	Ramp Width (in)	48.0
			N/A	Flare Type LT	N/A
			N/A	Flare Slope LT (%)	N/A
			N/A	Flare Traversable LT?	N/A
			N/A	Landing Length (in)	N/A
			N/A	Landing Width (in)	N/A
			N/A	Landing Slope (%)	N/A
			N/A	Landing X Slope (%)	N/A
<p>Surveyor Notes:</p> <p>N/A</p> <p>PROW/ADA:</p> <p>R304.2.2, R304.5.3</p>			N/A	Flare Type RT	N/A
			N/A	Flare Slope RT (%)	N/A
			N/A	Flare Traversable RT?	N/A
			N/A	DWS Provided?	N/A
			N/A	DWS Contrast?	N/A
			N/A	DWS Length (in)	N/A
			N/A	DWS Full Width?	N/A
			N/A	DWS Offset (in)	N/A
			N/A	Shared Landing?	N/A
			N/A	Gutter Ponding?	N/A
			N/A	Gutter Lip Ht (in)	N/A
			N/A	Painted X Walk1?	No
				X Walk 1 Direction	To NE

N/A	X Walk 1 Width (in)	N/A
				X Walk 1 Slope (%)	1.2
				X Walk 1 X Slope (%)	1.1
			N/A	Ramp inside XWalk1?	N/A
				Road Slope (%)	1.7
				Road X Slope (%)	0.9
			N/A	Any Obstructions?	N/A
				Obstruction Type	
Total Cost:			\$	3200.00
