# Access Compliance Report

## Public Rights-of-Way

### (Curb Ramps)

| Intersection ID: 23021 | Main Street: OLD_PROVIDENCE_RD | Cross Street: LANDING_VIEW_LN | Location: E |

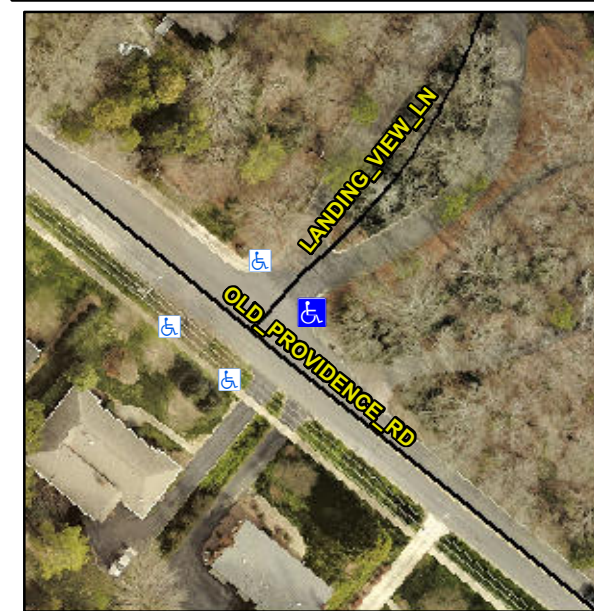
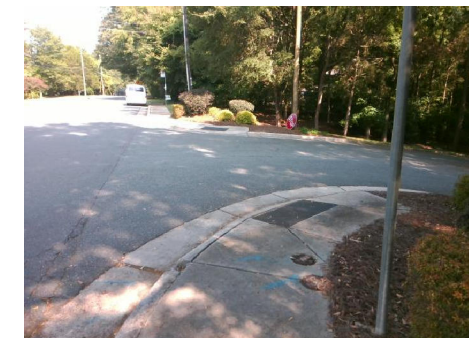
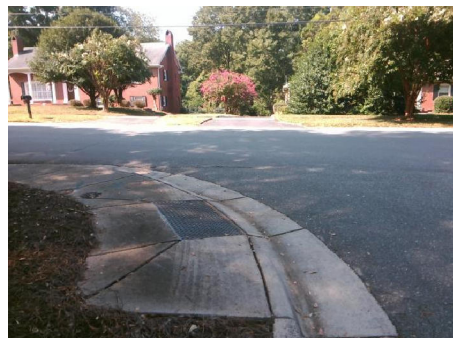
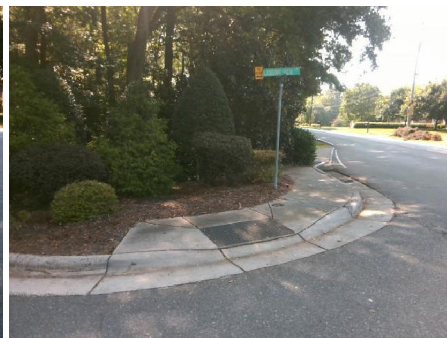
| ADA ID: 01F1C01B4CF5 | Ramp Type: PerpDiag | Initial Pass/Fail: Fail | Overall Compliance: No |

**Not Found, R304.2.2, R304.5.3**

| Compliance | Description | Data | Compliance | Description | Data |
|---|---|---|---|---|---|
| N/A | Ramp Length (in) | 26.0 | No | Ramp Slope (%) | 11.7 |
| Yes | Ramp Width (in) | 48.0 | No | Ramp XSlope (%) | 3.8 |

**Remove & Replace Curb Ramp With Two New Directional Ramps or Equivalent.**
