Access Compliance Report

Public Rights-of-Way

(Curb Ramps)

Intersection ID: 12867	Main Street: ENFIELD_RD	Cross Street: KILBORNE_DR	Location: NE
ADA ID: 01F305C18EDD	Ramp Type: Perp	Initial Pass/Fail: Fail	Overall Compliance: No
Codes/Mitigation Info/Possible Solution			Severity Score: 10
			Field Measurements/Component Compliance

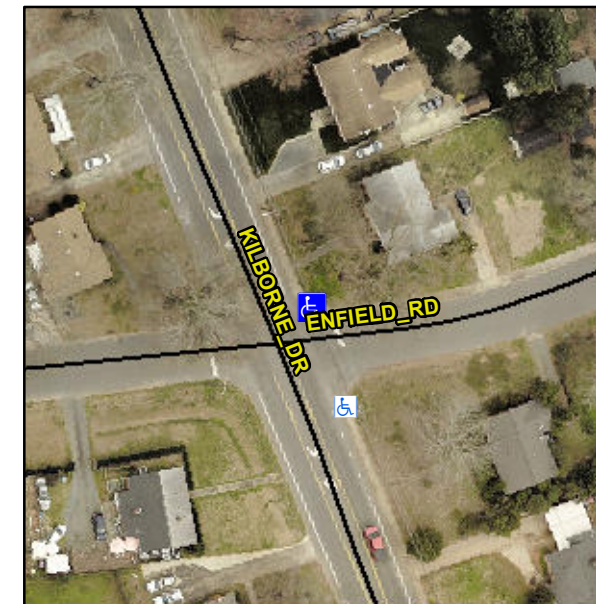
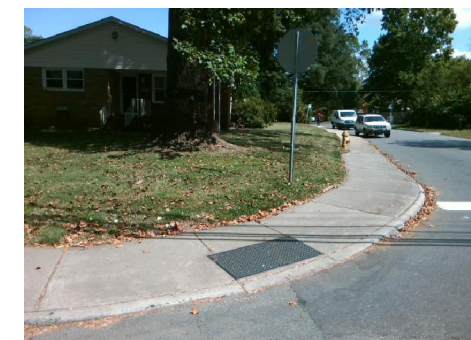
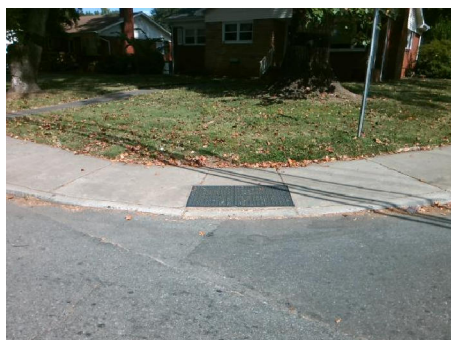
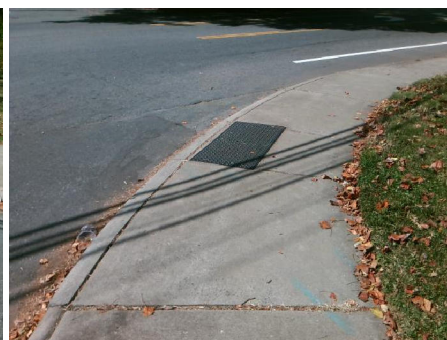
Not Found, R304.5.1, R304.5.3

Compliance	Description	Data	Compliance	Description	Data
N/A	Ramp Length (in)	61.0	Yes	Ramp Slope (%)	7.4
No	Ramp Width (in)	38.0	No	Ramp XSlope (%)	3.1
N/A	Flare Type LT	N/A	N/A	Flare Type RT	N/A
N/A	Flare Slope LT (%)	N/A	N/A	Flare Slope RT (%)	N/A
N/A	Flare Traversable LT?	N/A	N/A	Flare Traversable RT?	N/A
N/A	Landing Length (in)	N/A	N/A	DWS Provided?	N/A
N/A	Landing Width (in)	N/A	N/A	DWS Contrast?	N/A
N/A	Landing Slope (%)	N/A	N/A	DWS Length (in)	N/A
N/A	Landing X Slope (%)	N/A	N/A	DWS Full Width?	N/A
N/A	Landing Curb? (Y/N)	N/A	N/A	DWS Offset (in)	N/A
N/A	Shared Landing?	N/A			
N/A	Gutter Ponding?	N/A	N/A	Gutter Slope (%)	N/A
N/A	Gutter Lip Ht (in)	N/A	N/A	Gutter X Slope (%)	N/A
N/A	Painted X Walk1?	No	N/A	Painted X Walk2?	N/A
	X Walk 1 Direction	To S		X Walk 2 Direction	N/A
N/A	X Walk 1 Width (in)	N/A	N/A	X Walk 2 Width (in)	N/A
	X Walk 1 Slope (%)	3.8		X Walk 2 Slope (%)	N/A
	X Walk 1 X Slope (%)	3.4		X Walk 2 X Slope (%)	N/A

N/A	Ramp inside XWalk1?	N/A	N/A	Ramp inside XWalk2?	N/A
	Road Slope (%)	N/A	N/A	Clear Space?	N/A
	Road X Slope (%)	N/A	N/A	Clear Space to XWalk (in)	N/A
N/A	Any Obstructions?	N/A	N/A	Storm Grate/Utility Hazard?	N/A
	Obstruction Type			Storm Grate/Utility Type	
		N/A			N/A
			Yes	Surface Condition? (G/P)	Good

Remove & Replace Entire Ramp.

Total Cost: \$ 1850.00
