Access Compliance Report Public Rights-of-Way (Curb Ramps)

Intersection ID: 11867 Main Street: E_17TH_ST Cross Street: SEIGLE_AV Location:

ADA ID: 0201F3B9C487 **Overall Compliance: No** Ramp Type: Perp Initial Pass/Fail: Fail Severity Score: 33.75

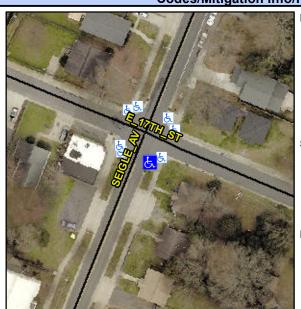
Field Measurements/Component Compliance							
	Compliance Description		Data	Compl	Compliance Description		
	N/A	Ramp Length (in)	76.0	Yes	Ramp Slope (%)	5.7	
	No	Ramp Width (in)	47.0	No	Ramp XSlope (%)	8.5	
	N/A	Flare Type LT	N/A	N/A	Flare Type RT	N/A	
	N/A	Flare Slope LT (%)	N/A	N/A	Flare Slope RT (%)	N/A	
	N/A	Flare Traversable LT?	N/A	N/A	Flare Traversable RT?	N/A	
	N/A	Landing Length (in)	N/A	N/A	DWS Provided?	N/A	
	N/A	Landing Width (in)	N/A	N/A	DWS Contrast?	N/A	
	N/A	Landing Slope (%)	N/A	N/A	DWS Length (in)	N/A	
	N/A	Landing X Slope (%)	N/A	N/A	DWS Full Width?	N/A	
	N/A	Landing Curb? (Y/N)	N/A	N/A	DWS Offset (in)	N/A	
	N/A	Shared Landing?	N/A				
	N/A	Gutter Ponding?	N/A	N/A	Gutter Slope (%)	N/A	
	N/A	Gutter Lip Ht (in)	0.5	N/A	Gutter X Slope (%)	N/A	
	N/A	Painted X Walk1?	No	N/A	Painted X Walk2?	N/A	
		X Walk 1 Direction	To NW		X Walk 2 Direction	N/A	
	N/A	X Walk 1 Width (in)	N/A	N/A	X Walk 2 Width (in)	N/A

X Walk 1 Slope (%)	1.9		X Walk 2 Slope (%)	N/A	
		X Walk 1 X Slope (%)	6.8		X Walk 2 X Slope (%)	N/A	
	N/A	Ramp inside XWalk1?	N/A	N/A	Ramp inside XWalk2?	N/A	
		Road Slope (%)	N/A	N/A	Clear Space?	N/A	
		Road X Slope (%)	N/A	N/A	Clear Space to XWalk (in)	N/A	
	N/A	Any Obstructions?	N/A	N/A	Storm Grate/Utility Hazard?	N/A	
		Obstruction Type			Storm Grate/Utility Type		
			N/A			N/A	
				Yes	Surface Condition? (G/P)	Good

Possible Solutions:	Con
Remove & Replace Entire Ramp.	N/A
·	No
	N/A
	N/A
	N/A
	N/A
Surveyor Notes:	N/A
N/A	N/A
	N/A
	N/A
	N/A
PROW/ADA:	N/A
R304.5.1, R304.5.3	N/A
, , , , , , , , , , , , , , , , , , , ,	N/A
	N/A
	N/A

Total Cost: 1850.00
