Access Compliance Report

Public Rights-of-Way

(Curb Ramps)

| Intersection ID: 43887 | Main Street: DOGGETT_ST | Cross Street: ABBOTT_ST | Location: NW |

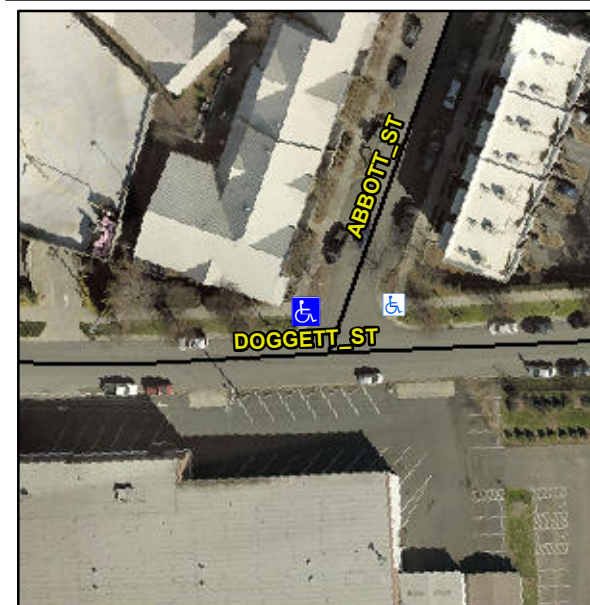
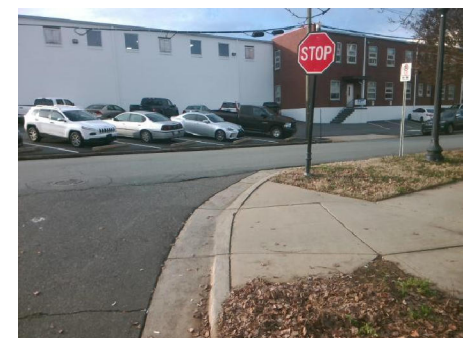
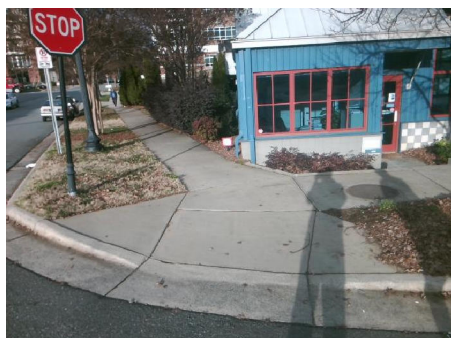
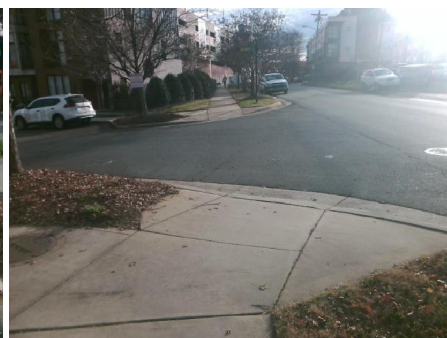
| ADA ID: 021374BDBB6C | Ramp Type: PerpDiag | Initial Pass/Fail: Fail | Overall Compliance: No |
| Severity Score: 25 | | | |

R304.5.3

| Compliance | Description | Data | Compliance | Description | Data |
|---|---|---|---|---|---|
| Yes | Ramp Width (in) | 70.0 | No | Ramp XSlope (%) | 9.7 |

Remove & Replace Curb Ramp With Two New Directional Ramps or Equivalent.

Total Cost: \$ 3200.00
