Access Compliance Report

Public Rights-of-Way

(Curb Ramps)

Intersection ID: 28076	Main Street: ALEXANDER MARTIN AV	Cross Street: REA RD	Location: E
ADA ID: 0215BA11FBF9	Ramp Type: Perp	Initial Pass/Fail: Fail	Overall Compliance: No
Codes/Mitigation Info/Possible Solution		Field Measurements/Component Compliance	
Severity Score: 13.75

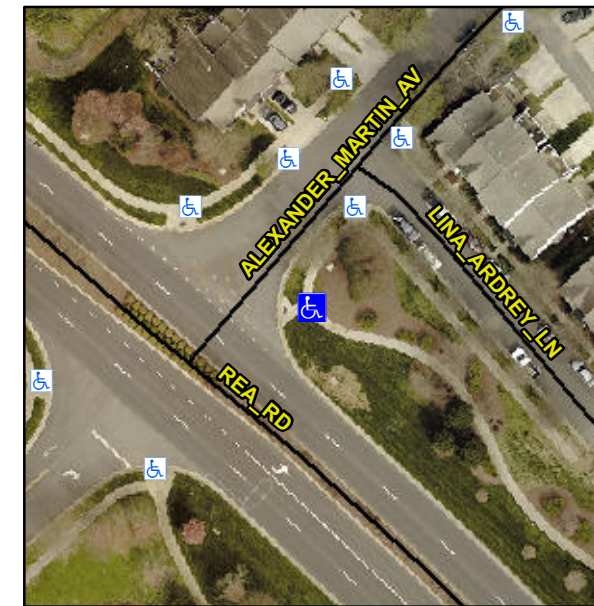
Not Found, R304.2.2, R304.5.3

Compliance	Description	Data	Compliance	Description	Data
N/A	Ramp Length (in)	142.0	No	Ramp Slope (%)	9.1
Yes	Ramp Width (in)	57.0	No	Ramp XSlope (%)	4.7
N/A	Flare Type LT	N/A	N/A	Flare Type RT	N/A
N/A	Flare Slope LT (%)	N/A	N/A	Flare Slope RT (%)	N/A
N/A	Flare Traversable LT?	N/A	N/A	Flare Traversable RT?	N/A
N/A	Landing Length (in)	N/A	N/A	DWS Provided?	N/A
N/A	Landing Width (in)	N/A	N/A	DWS Contrast?	N/A
N/A	Landing Slope (%)	N/A	N/A	DWS Length (in)	N/A
N/A	Landing X Slope (%)	N/A	N/A	DWS Full Width?	N/A
N/A	Landing Curb? (Y/N)	N/A	N/A	DWS Offset (in)	N/A
N/A	Shared Landing?	N/A			
N/A	Gutter Ponding?	N/A	N/A	Gutter Slope (%)	N/A
N/A	Gutter Lip Ht (in)	N/A	N/A	Gutter X Slope (%)	N/A
N/A	Painted X Walk1?	No	N/A	Painted X Walk2?	N/A
	X Walk 1 Direction	To NE		X Walk 2 Direction	N/A
N/A	X Walk 1 Width (in)	N/A	N/A	X Walk 2 Width (in)	N/A
	X Walk 1 Slope (%)	1.3		X Walk 2 Slope (%)	N/A
	X Walk 1 X Slope (%)	2.1		X Walk 2 X Slope (%)	N/A

N/A	Ramp inside XWalk1?	N/A	N/A	Ramp inside XWalk2?	N/A
	Road Slope (%)	N/A	N/A	Clear Space?	N/A
	Road X Slope (%)	N/A	N/A	Clear Space to XWalk (in)	N/A
N/A	Any Obstructions?	N/A	N/A	Storm Grate/Utility Hazard?	N/A
	Obstruction Type			Storm Grate/Utility Type	
		N/A			N/A
			Yes	Surface Condition? (G/P)	Good

Possible Solutions:

Remove & Replace Entire Ramp.
