# Access Compliance Report

## Public Rights-of-Way

### (Curb Ramps)

Intersection ID: 16456	Main Street: MONROE_RD	Cross Street: SUMMEY_AV	Location: SE
ADA ID: 0217DCCE07FB	Ramp Type: PerpDiag	Initial Pass/Fail: Fail	Overall Compliance: No
Codes/Mitigation Info/Possible Solution		Field Measurements/Component Compliance	
Severity Score: 21.25

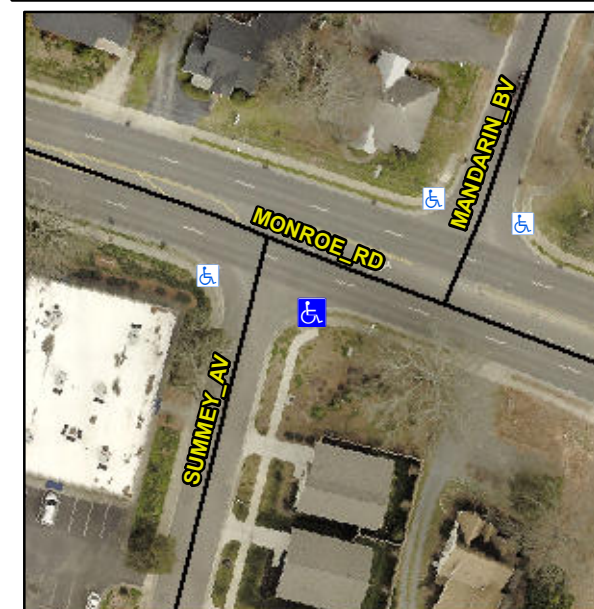
**Not Found, R304.5.1, R304.5.3**

Compliance	Description	Data	Compliance	Description	Data
N/A	Ramp Length (in)	84.0	Yes	Ramp Slope (%)	5.1
No	Ramp Width (in)	46.0	No	Ramp XSlope (%)	5.2
N/A	Flare Type LT	N/A	N/A	Flare Type RT	N/A
N/A	Flare Slope LT (%)	N/A	N/A	Flare Slope RT (%)	N/A
N/A	Flare Traversable LT?	N/A	N/A	Flare Traversable RT?	N/A
N/A	Landing Length (in)	N/A	N/A	DWS Provided?	N/A
N/A	Landing Width (in)	N/A	N/A	DWS Contrast?	N/A
N/A	Landing Slope (%)	N/A	N/A	DWS Length (in)	N/A
N/A	Landing X Slope (%)	N/A	N/A	DWS Full Width?	N/A
N/A	Landing Curb? (Y/N)	N/A	N/A	DWS Offset (in)	N/A
N/A	Shared Landing?	N/A			
N/A	Gutter Ponding?	N/A	N/A	Gutter Slope (%)	N/A
N/A	Gutter Lip Ht (in)	N/A	N/A	Gutter X Slope (%)	N/A
N/A	Painted X Walk1?	No	N/A	Painted X Walk2?	No
	X Walk 1 Direction	To NE		X Walk 2 Direction	To NW
N/A	X Walk 1 Width (in)	N/A	N/A	X Walk 2 Width (in)	N/A
	X Walk 1 Slope (%)	1.9		X Walk 2 Slope (%)	1.0
	X Walk 1 X Slope (%)	1.9		X Walk 2 X Slope (%)	2.1

N/A	Ramp inside XWalk1?	N/A	N/A	Ramp inside XWalk2?	N/A
	Road Slope (%)	2.1	N/A	Clear Space?	N/A
	Road X Slope (%)	0.6	N/A	Clear Space to XWalk (in)	N/A
N/A	Any Obstructions?	N/A	N/A	Storm Grate/Utility Hazard?	N/A
	Obstruction Type			Storm Grate/Utility Type	
		N/A			N/A
			Yes	Surface Condition? (G/P)	Good

**Remove & Replace Curb Ramp With Two New Directional Ramps or Equivalent.**

Total Cost: \$ 3200.00
