# Access Compliance Report

## Public Rights-of-Way

| Intersection ID: 10814 | Main Street: CLAY_AV | Cross Street: EFFINGHAM_RD | Location: NW |
| ADA ID: 021CDC98192D | Ramp Type: Directional1 | Initial Pass/Fail: Fail | Overall Compliance: No |

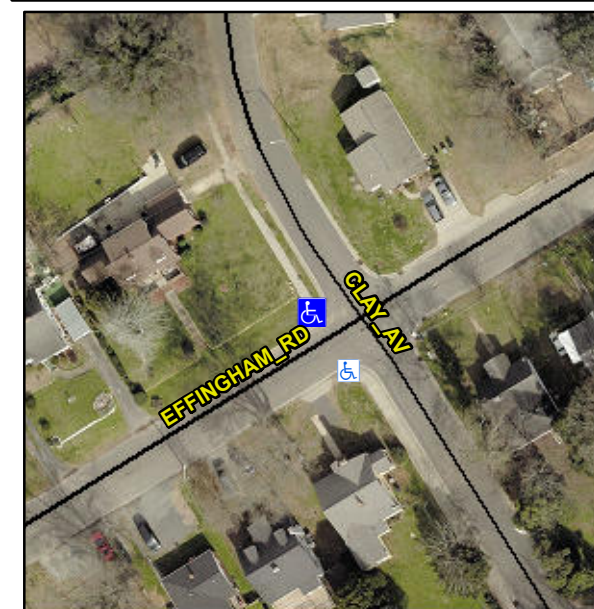
| Severity Score: 25 | | | |

**R304.2.2**

| Compliance | Description | Data | Compliance | Description | Data |
|---|---|---|---|---|---|
| No | Ramp Slope (%) | 12.7 | N/A | Grade Break XSlope (%) | 0.0 |

**Remove & Replace Entire Ramp.**

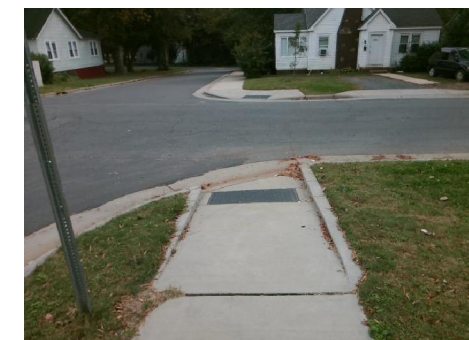
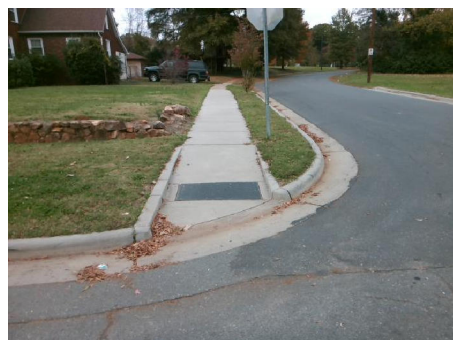
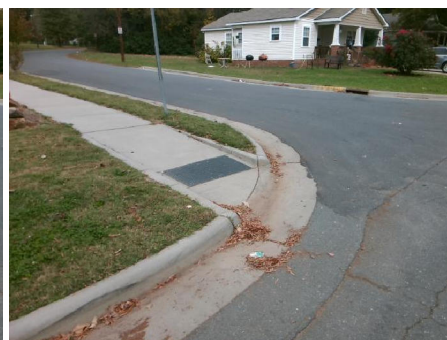
| Compliance | Description | Data | Compliance | Description | Data |
|---|---|---|---|---|---|
| | Obstruction Type | | Yes | Surface Condition? (G/P) | Good |
