Access Compliance Report

Public Rights-of-Way

(Curb Ramps)

Intersection ID: 30575	Main Street: CIRCLEGREEN_DR	Cross Street: GROVE_CREEK_LN	Location: NE
ADA ID: 022C51033BF2	Ramp Type: PerpDiag	Initial Pass/Fail: Fail	Overall Compliance: No
		Severity Score: 12.5

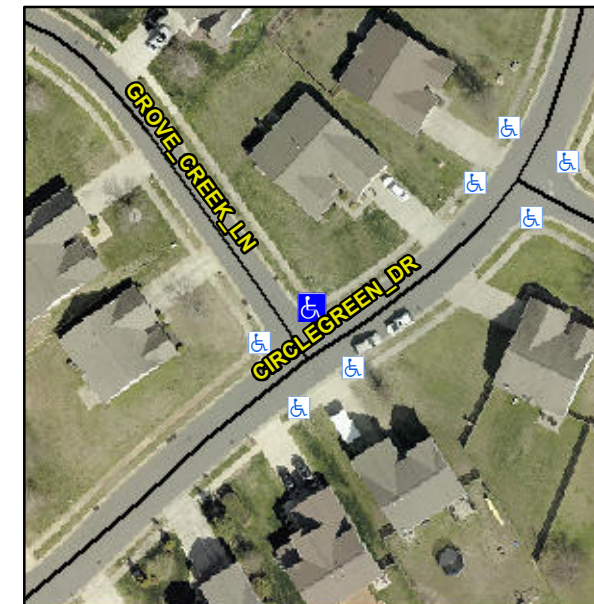
Compliance	Description	Data	Compliance	Description	Data
N/A	Ramp Length (in)	51.0	No	Ramp Slope (%)	8.6
Yes	Ramp Width (in)	48.0	Yes	Ramp XSlope (%)	0.6
N/A	Flare Type LT	N/A	N/A	Flare Type RT	N/A
N/A	Flare Slope LT (%)	N/A	N/A	Flare Slope RT (%)	N/A
N/A	Flare Traversable LT?	N/A	N/A	Flare Traversable RT?	N/A
N/A	Landing Length (in)	N/A	N/A	DWS Provided?	N/A
N/A	Landing Width (in)	N/A	N/A	DWS Contrast?	N/A
N/A	Landing Slope (%)	N/A	N/A	DWS Length (in)	N/A
N/A	Landing X Slope (%)	N/A	N/A	DWS Full Width?	N/A
N/A	Landing Curb? (Y/N)	N/A	N/A	DWS Offset (in)	N/A
N/A	Shared Landing?	N/A			
N/A	Gutter Ponding?	N/A	N/A	Gutter Slope (%)	N/A
N/A	Gutter Lip Ht (in)	N/A	N/A	Gutter X Slope (%)	N/A
N/A	Painted X Walk1?	No	N/A	Painted X Walk2?	No
	X Walk 1 Direction	To SW		X Walk 2 Direction	To SE
N/A	X Walk 1 Width (in)	N/A	N/A	X Walk 2 Width (in)	N/A
	X Walk 1 Slope (%)	2.2		X Walk 2 Slope (%)	1.8
	X Walk 1 X Slope (%)	2.4		X Walk 2 X Slope (%)	0.7

N/A	Ramp inside XWalk1?	N/A	N/A	Ramp inside XWalk2?	N/A
	Road Slope (%)	1.8	N/A	Clear Space?	N/A
	Road X Slope (%)	2.5	N/A	Clear Space to XWalk (in)	N/A
N/A	Any Obstructions?	N/A	N/A	Storm Grate/Utility Hazard?	N/A
	Obstruction Type			Storm Grate/Utility Type	
		N/A			N/A
			Yes	Surface Condition? (G/P)	Good

Remove & Replace Curb Ramp With Two New Directional Ramps or Equivalent.

R304.2.2
