Access Compliance Report Public Rights-of-Way (Curb Ramps)

Intersection ID: 14017Main Street:STILWELL_OAKS_CRCross Street:WILORA_LAKE_RDLocation:SEADA ID: 022D3EBFE903Ramp Type:BlendTrans1Initial Pass/Fail:FailOverall Compliance:NoSeverity Score:10

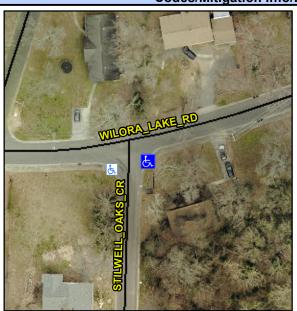
CURB GAP 1.0

Not Found, R304.5.1, R304.5.3

Field Measurements/Component Compliance					
Compliance Description		Data	Comp	liance Description	Data
N/A	Ramp Length (in)	60.0	Yes	BlendTrans Slope (%)	2.4
No	Ramp Width (in)	40.0	No	BlendTrans XSlope (%)	2.6
N/A	Flare Type LT	N/A	N/A	Flare Type RT	N/A
N/A	Flare Slope LT (%)	N/A	N/A	Flare Slope RT (%)	N/A
N/A	Flare Traversable LT?	N/A	N/A	Flare Traversable RT?	N/A
N/A	Landing Length (in)	N/A	N/A	DWS Provided?	N/A
N/A	Landing Width (in)	N/A	N/A	DWS Contrast?	N/A
N/A	Landing Slope (%)	N/A	N/A	DWS Length (in)	N/A
N/A	Landing X Slope (%)	N/A	N/A	DWS Full Width?	N/A
N/A	Landing Curb? (Y/N)	N/A	N/A	DWS Offset (in)	N/A
N/A	Shared Landing?	N/A			
N/A	Gutter Ponding?	N/A	N/A	Gutter Slope (%)	N/A
N/A	Gutter Lip Ht (in)	N/A	N/A	Gutter X Slope (%)	N/A
N/A	Painted X Walk1?	No	N/A	Painted X Walk2?	N/A
	X Walk 1 Direction	To W		X Walk 2 Direction	N/A
	X Walk 1 Width (in)	N/A		X Walk 2 Width (in)	N/A
	X Walk 1 Slope (%)	2.4		X Walk 2 Slope (%)	N/A

X Walk 1 X Slope (%)	4.1		X Walk 2 X Slope (%)	N/A
N/A	Ramp inside XWalk1?	N/A	N/A	Ramp inside XWalk2?	N/A
	Road Slope (%)	4.1		Clear Space?	N/A
	Road X Slope (%)	2.4	N/A	Clear Space to XWalk (in)	N/A
N/A	Any Obstructions?	N/A	N/A	Storm Grate/Utility Hazard?	N/A
	Obstruction Type			Storm Grate/Utility Type	
		N/A			N/A
			Yes	Surface Condition? (G/P)	Good
Consideration of the second			No	Curb Slope (%)	20.4

Remove & Replace Curb Ramp With Two New Directional Ramps or Equivalent.
