Access Compliance Report

Public Rights-of-Way

(Curb Ramps)

Intersection ID: 11349	Main Street: N_DAVIDSON_ST	Cross Street: PARKWOOD_AV	Location: E
ADA ID: 023A7ED207C2	Ramp Type: Perp	Initial Pass/Fail: Fail	Overall Compliance: No
Codes/Mitigation Info/Possible Solution		Field Measurements/Component Compliance	
Severity Score: 8.75

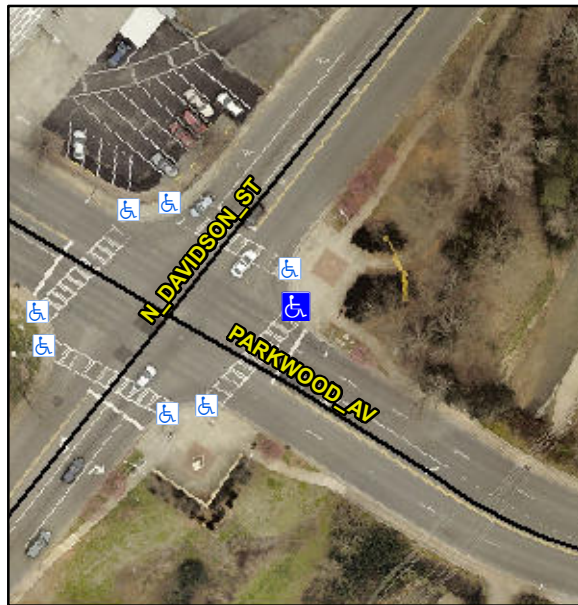
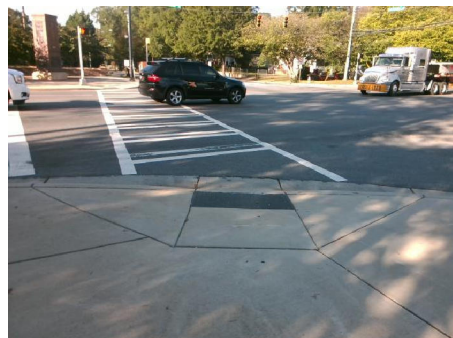
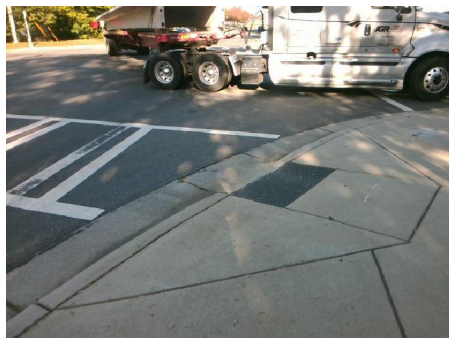
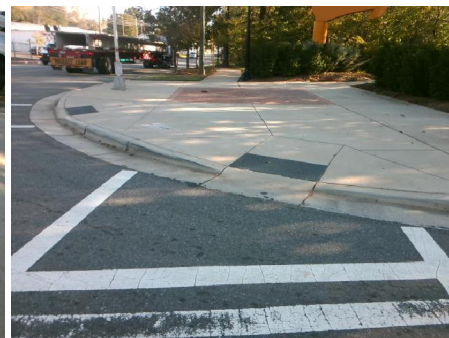
Not Found, R304.5.1

Compliance	Description	Data	Compliance	Description	Data
N/A	Ramp Length (in)	65.5	Yes	Ramp Slope (%)	5.1
No	Ramp Width (in)	46.5	Yes	Ramp XSlope (%)	0.4
N/A	Flare Type LT	N/A	N/A	Flare Type RT	N/A
N/A	Flare Slope LT (%)	N/A	N/A	Flare Slope RT (%)	N/A
N/A	Flare Traversable LT?	N/A	N/A	Flare Traversable RT?	N/A
N/A	Landing Length (in)	N/A	N/A	DWS Provided?	N/A
N/A	Landing Width (in)	N/A	N/A	DWS Contrast?	N/A
N/A	Landing Slope (%)	N/A	N/A	DWS Length (in)	N/A
N/A	Landing X Slope (%)	N/A	N/A	DWS Full Width?	N/A
N/A	Landing Curb? (Y/N)	N/A	N/A	DWS Offset (in)	N/A
N/A	Shared Landing?	N/A			
N/A	Gutter Ponding?	N/A	N/A	Gutter Slope (%)	N/A
N/A	Gutter Lip Ht (in)	N/A	N/A	Gutter X Slope (%)	N/A
N/A	Painted X Walk1?	Yes	N/A	Painted X Walk2?	N/A
	X Walk 1 Direction	To SW		X Walk 2 Direction	N/A
N/A	X Walk 1 Width (in)	111.0	N/A	X Walk 2 Width (in)	N/A
	X Walk 1 Slope (%)	1.4		X Walk 2 Slope (%)	N/A
	X Walk 1 X Slope (%)	0.5		X Walk 2 X Slope (%)	N/A

N/A	Ramp inside XWalk1?	Yes	N/A	Ramp inside XWalk2?	N/A
	Road Slope (%)	N/A	N/A	Clear Space?	N/A
	Road X Slope (%)	N/A	N/A	Clear Space to XWalk (in)	N/A
N/A	Any Obstructions?	N/A	N/A	Storm Grate/Utility Hazard?	N/A
	Obstruction Type			Storm Grate/Utility Type	
		N/A			N/A
		Yes		Surface Condition? (G/P)	Good

Possible Solutions:

Remove & Replace Entire Ramp.

Total Cost: \$ 1850.00
