Access Compliance Report

Public Rights-of-Way

(Curb Ramps)

| Intersection ID: 25356 | Main Street: PLANTERS_KNOB_LN | Cross Street: ROCKY_TRACE_WY | Location: NW |

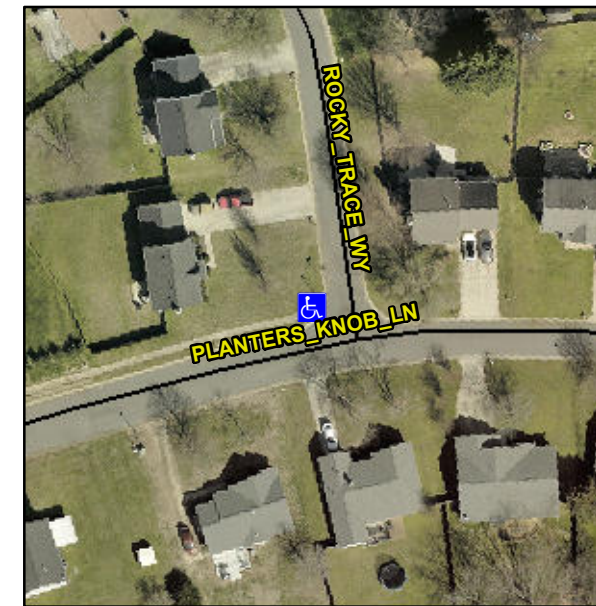
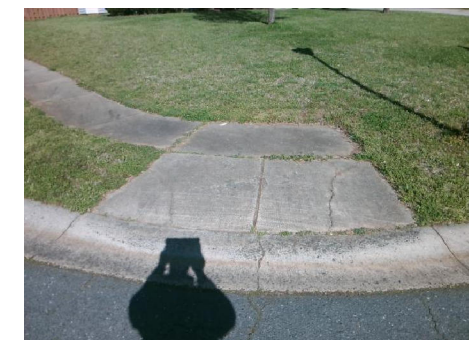
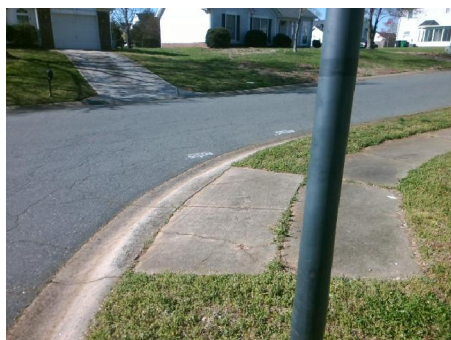
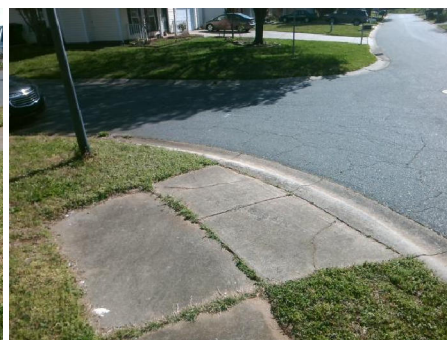
| ADA ID: 023CC47B73EF | Ramp Type: PerpDiag | Initial Pass/Fail: Fail | Overall Compliance: No |

Not Found, R304.2.2, R304.5.3

| Compliance | Description | Data | Compliance | Description | Data |
|---|---|---|---|---|---|
| N/A | Ramp Length (in) | 51.0 | No | Ramp Slope (%) | 10.8 |
| Yes | Ramp Width (in) | 48.0 | No | Ramp XSlope (%) | 3.4 |

Remove & Replace Curb Ramp With Two New Directional Ramps or Equivalent.
