Access Compliance Report

Public Rights-of-Way

(Curb Ramps)

Intersection ID: 12336	Main Street: CAMP_GREENE_ST	Cross Street: GREENLAND_AV	Location: NE
ADA ID: 024DF6AEB6B8	Ramp Type: Perp	Initial Pass/Fail: Fail	Overall Compliance: No
		Severity Score: 12.5

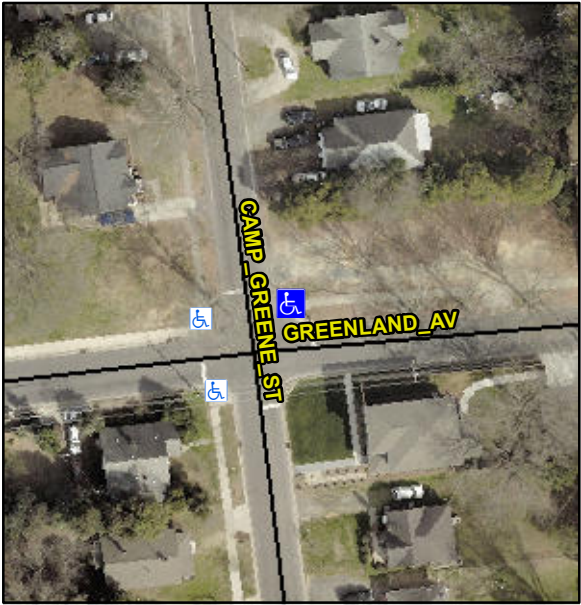
Possible Solutions:		Compliance	Description	Data
	Remove & Replace Entire Ramp.		No	Ramp Length (in)	59.0
			Yes	Ramp Width (in)	48.0
			N/A	Flare Type LT	N/A
			N/A	Flare Slope LT (%)	N/A
			N/A	Flare Traversable LT?	N/A
			N/A	Landing Length (in)	N/A
			N/A	Landing Width (in)	N/A
			N/A	Landing Slope (%)	N/A
			N/A	Landing X Slope (%)	N/A
<p>Surveyor Notes:</p> <p>N/A</p> <p>PROW/ADA:</p> <p>Not Found, R304.2.2</p>			N/A	Flare Type RT	N/A
			N/A	Flare Slope RT (%)	N/A
			N/A	Flare Traversable RT?	N/A
			N/A	DWS Provided?	N/A
			N/A	DWS Contrast?	N/A
			N/A	DWS Length (in)	N/A
			N/A	DWS Full Width?	N/A
			N/A	DWS Offset (in)	N/A
			N/A	Shared Landing?	N/A
			N/A	Gutter Ponding?	N/A
			N/A	Gutter Lip Ht (in)	N/A
			N/A	Painted X Walk1?	No
				X Walk 1 Direction	To W
			N/A	X Walk 1 Width (in)	N/A
				X Walk 1 Slope (%)	1.4
				X Walk 1 X Slope (%)	3.5

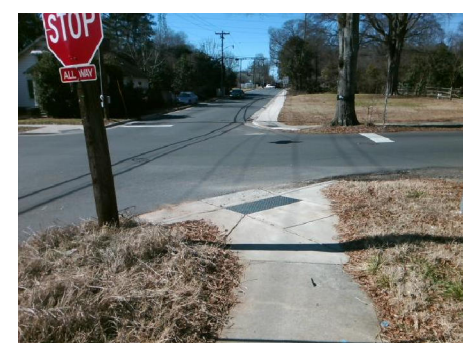
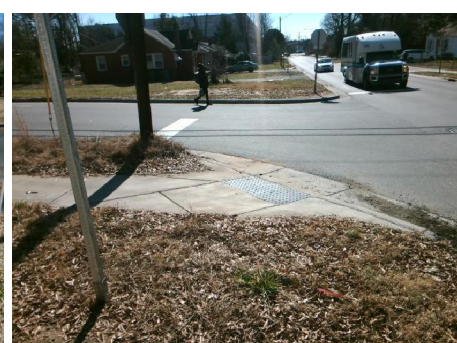
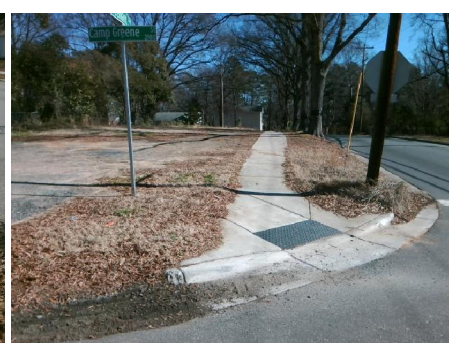
N/A	Ramp inside XWalk1?	N/A
			N/A	Road Slope (%)	N/A
			N/A	Road X Slope (%)	N/A
			N/A	Any Obstructions?	N/A
Total Cost:		\$ 1850.00		Obstruction Type	
			N/A		N/A
			Yes	Surface Condition? (G/P)	Good
