Access Compliance Report

Public Rights-of-Way

(Curb Ramps)

Intersection ID: 9327	Main Street: REDBUD_ST	Cross Street: SANDERS_AV	Location:	SE
ADA ID: 025E384A1B0E	Ramp Type: Perp	Initial Pass/Fail: Fail	Overall Compliance: No	Severity Score: 10
Codes/Mitigation Info/Possible Solution		Field Measurements/Component Compliance

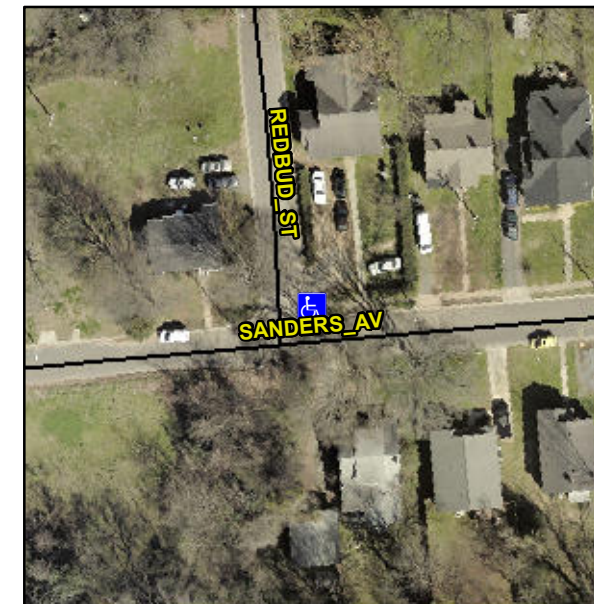
Not Found, R304.5.1, R304.5.3

Compliance	Description	Data	Compliance	Description	Data
N/A	Ramp Length (in)	74.0	Yes	Ramp Slope (%)	7.9
No	Ramp Width (in)	46.0	No	Ramp XSlope (%)	2.7
N/A	Flare Type LT	N/A	N/A	Flare Type RT	N/A
N/A	Flare Slope LT (%)	N/A	N/A	Flare Slope RT (%)	N/A
N/A	Flare Traversable LT?	N/A	N/A	Flare Traversable RT?	N/A
N/A	Landing Length (in)	N/A	N/A	DWS Provided?	N/A
N/A	Landing Width (in)	N/A	N/A	DWS Contrast?	N/A
N/A	Landing Slope (%)	N/A	N/A	DWS Length (in)	N/A
N/A	Landing X Slope (%)	N/A	N/A	DWS Full Width?	N/A
N/A	Landing Curb? (Y/N)	N/A	N/A	DWS Offset (in)	N/A
N/A	Shared Landing?	N/A			
N/A	Gutter Ponding?	N/A	N/A	Gutter Slope (%)	N/A
N/A	Gutter Lip Ht (in)	N/A	N/A	Gutter X Slope (%)	N/A
N/A	Painted X Walk1?	No	N/A	Painted X Walk2?	N/A
	X Walk 1 Direction	To W		X Walk 2 Direction	N/A
N/A	X Walk 1 Width (in)	N/A	N/A	X Walk 2 Width (in)	N/A
	X Walk 1 Slope (%)	0.9		X Walk 2 Slope (%)	N/A
	X Walk 1 X Slope (%)	0.4		X Walk 2 X Slope (%)	N/A

N/A	Ramp inside XWalk1?	N/A	N/A	Ramp inside XWalk2?	N/A
	Road Slope (%)	0.4	N/A	Clear Space?	N/A
	Road X Slope (%)	0.9	N/A	Clear Space to XWalk (in)	N/A
N/A	Any Obstructions?	N/A	N/A	Storm Grate/Utility Hazard?	N/A
	Obstruction Type			Storm Grate/Utility Type	
		N/A			N/A
			Yes	Surface Condition? (G/P)	Good

Possible Solutions:

Remove & Replace Entire Ramp.
