Access Compliance Report

Public Rights-of-Way

(Curb Ramps)

Intersection ID: 26308	Main Street: WEDDINGTON_RD	Cross Street: MCKEE_RD	Location: NW
ADA ID: 0260B583B373	Ramp Type: PerpDiag	Initial Pass/Fail: Fail	Overall Compliance: No
		Severity Score: 10

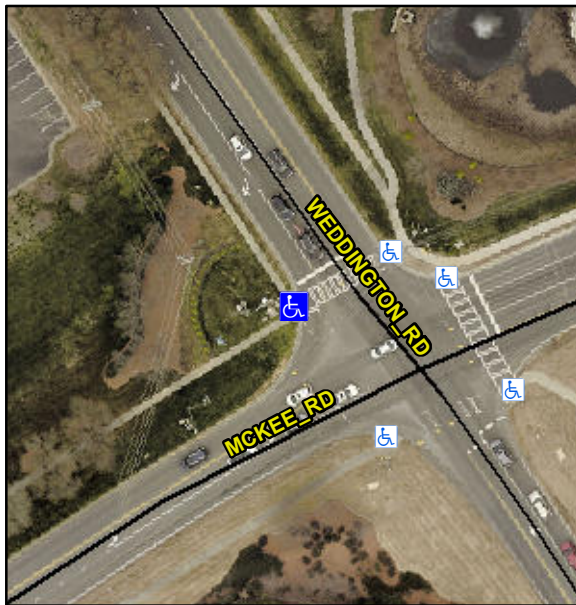
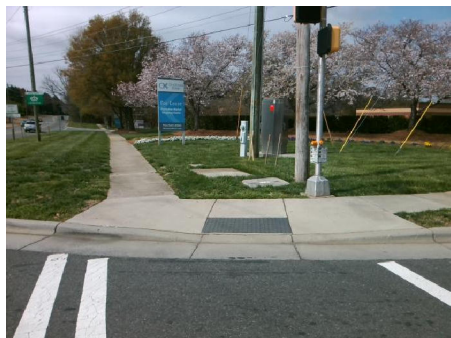
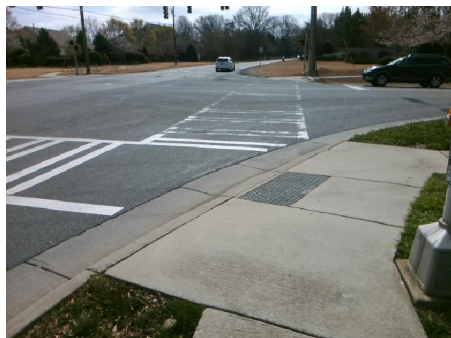
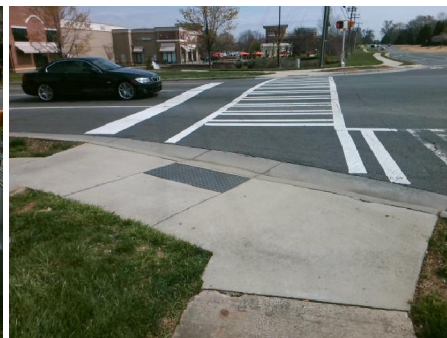
Not Found, R304.5.1, R304.5.3

Compliance	Description	Data	Compliance	Description	Data
N/A	Ramp Length (in)	67.0	Yes	Ramp Slope (%)	5.3
No	Ramp Width (in)	47.0	No	Ramp XSlope (%)	2.3
N/A	Flare Type LT	N/A	N/A	Flare Type RT	N/A
N/A	Flare Slope LT (%)	N/A	N/A	Flare Slope RT (%)	N/A
N/A	Flare Traversable LT?	N/A	N/A	Flare Traversable RT?	N/A
N/A	Landing Length (in)	N/A	N/A	DWS Provided?	N/A
N/A	Landing Width (in)	N/A	N/A	DWS Contrast?	N/A
N/A	Landing Slope (%)	N/A	N/A	DWS Length (in)	N/A
N/A	Landing X Slope (%)	N/A	N/A	DWS Full Width?	N/A
N/A	Landing Curb? (Y/N)	N/A	N/A	DWS Offset (in)	N/A
N/A	Shared Landing?	N/A			
N/A	Gutter Ponding?	N/A	N/A	Gutter Slope (%)	N/A
N/A	Gutter Lip Ht (in)	N/A	N/A	Gutter X Slope (%)	N/A
N/A	Painted X Walk1?	Yes	N/A	Painted X Walk2?	Yes
	X Walk 1 Direction	To S		X Walk 2 Direction	To E
N/A	X Walk 1 Width (in)	107.0	N/A	X Walk 2 Width (in)	107.0
	X Walk 1 Slope (%)	0.2		X Walk 2 Slope (%)	1.1
	X Walk 1 X Slope (%)	2.2		X Walk 2 X Slope (%)	0.5

N/A	Ramp inside XWalk1?	Yes	N/A	Ramp inside XWalk2?	Yes
	Road Slope (%)	0.9	N/A	Clear Space?	N/A
	Road X Slope (%)	1.0	N/A	Clear Space to XWalk (in)	N/A
N/A	Any Obstructions?	N/A	N/A	Storm Grate/Utility Hazard?	N/A
	Obstruction Type			Storm Grate/Utility Type	
		N/A			N/A
		Yes		Surface Condition? (G/P)	Good

Remove & Replace Curb Ramp With Two New Directional Ramps or Equivalent.
