Access Compliance Report

Public Rights-of-Way

(Curb Ramps)

| Intersection ID: N/A | Main Street: ABBEYDALE_DR | Cross Street: SOMERDALE_LN | Location: SW |

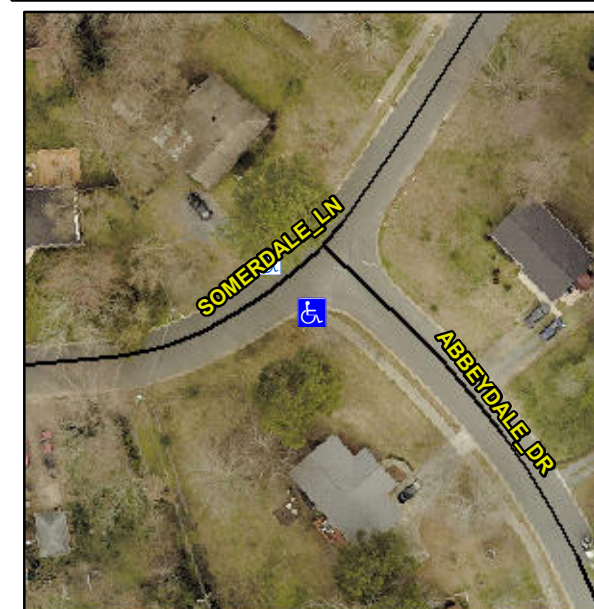
| ADA ID: 026A5A9624B7 | Ramp Type: PerpDiag | Initial Pass/Fail: Fail | Overall Compliance: No |
| Severity Score: 21.25 | | | |

R304.5.1, R304.2.2

| Compliance | Description | Data | Compliance | Description | Data |
|---|---|---|---|---|---|
| N/A | Ramp Length (in) | 65.0 | No | Ramp Slope (%) | 10.1 |
| No | Ramp Width (in) | 44.0 | Yes | Ramp XSlope (%) | 1.1 |

Remove & Replace Curb Ramp With Two New Directional Ramps or Equivalent.
