# Access Compliance Report

## Public Rights-of-Way

### (Curb Ramps)

Intersection ID: 6594	Main Street: DALE_AV	Cross Street: ROOK_RD	Location: S
ADA ID: 026CC5FFD9A8	Ramp Type: PerpDiag	Initial Pass/Fail: Fail	Overall Compliance: No
Severity Score: 12.5			
Codes/Mitigation Info/Possible Solution		Field Measurements/Component Compliance

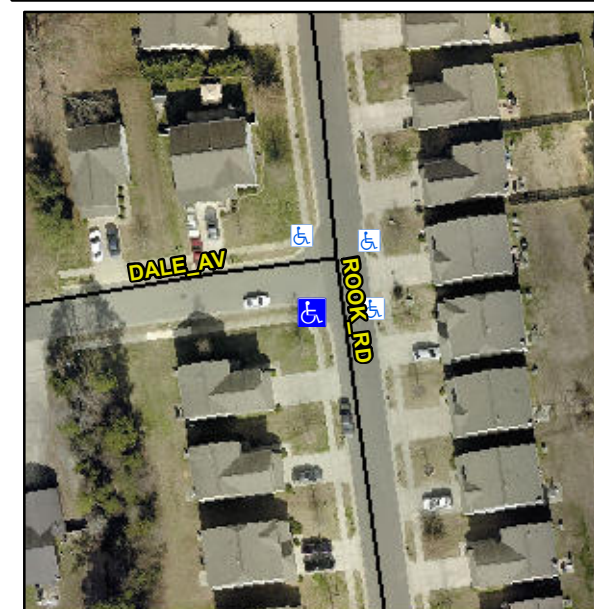
**Not Found, R304.2.2**

Compliance	Description	Data	Compliance	Description	Data
N/A	Ramp Length (in)	47.0	No	Ramp Slope (%)	8.5
Yes	Ramp Width (in)	48.0	Yes	Ramp XSlope (%)	1.5
N/A	Flare Type LT	N/A	N/A	Flare Type RT	N/A
N/A	Flare Slope LT (%)	N/A	N/A	Flare Slope RT (%)	N/A
N/A	Flare Traversable LT?	N/A	N/A	Flare Traversable RT?	N/A
N/A	Landing Length (in)	N/A	N/A	DWS Provided?	N/A
N/A	Landing Width (in)	N/A	N/A	DWS Contrast?	N/A
N/A	Landing Slope (%)	N/A	N/A	DWS Length (in)	N/A
N/A	Landing X Slope (%)	N/A	N/A	DWS Full Width?	N/A
N/A	Landing Curb? (Y/N)	N/A	N/A	DWS Offset (in)	N/A
N/A	Shared Landing?	N/A			
N/A	Gutter Ponding?	N/A	N/A	Gutter Slope (%)	N/A
N/A	Gutter Lip Ht (in)	N/A	N/A	Gutter X Slope (%)	N/A
N/A	Painted X Walk1?	No	N/A	Painted X Walk2?	No
	X Walk 1 Direction	To N		X Walk 2 Direction	To W
N/A	X Walk 1 Width (in)	N/A	N/A	X Walk 2 Width (in)	N/A
	X Walk 1 Slope (%)	0.2		X Walk 2 Slope (%)	2.1
	X Walk 1 X Slope (%)	2.9		X Walk 2 X Slope (%)	2.1

N/A	Ramp inside XWalk1?	N/A	N/A	Ramp inside XWalk2?	N/A
	Road Slope (%)	0.4	N/A	Clear Space?	N/A
	Road X Slope (%)	3.8	N/A	Clear Space to XWalk (in)	N/A
N/A	Any Obstructions?	N/A	N/A	Storm Grate/Utility Hazard?	N/A
	Obstruction Type			Storm Grate/Utility Type	
		N/A			N/A
		Yes		Surface Condition? (G/P)	Good

**Remove & Replace Curb Ramp With Two New Directional Ramps or Equivalent.**
