# Access Compliance Report

## Public Rights-of-Way

### (Curb Ramps)

| Intersection ID: 8592 | Main Street: PERIWINKLE_HILL_AV | Cross Street: IKEA_BV | Location: W |

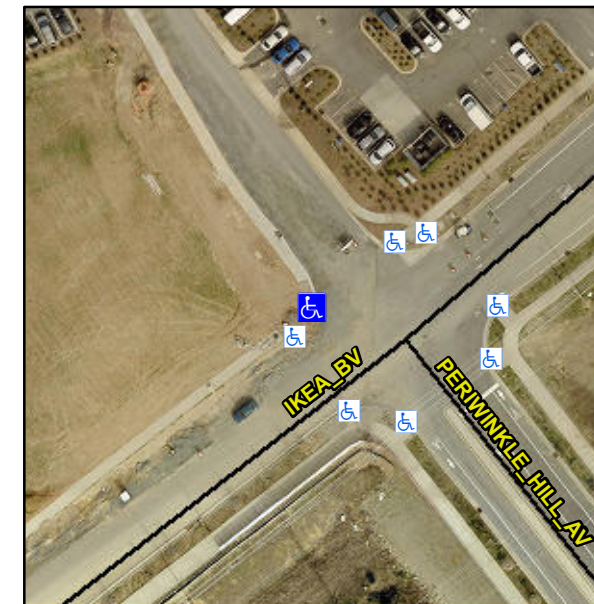
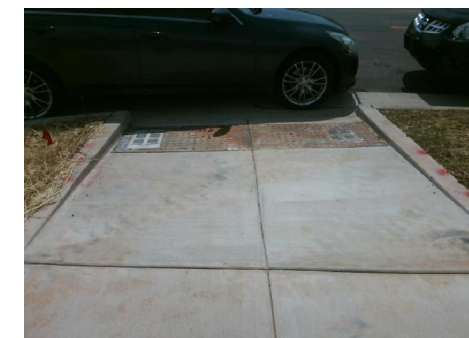
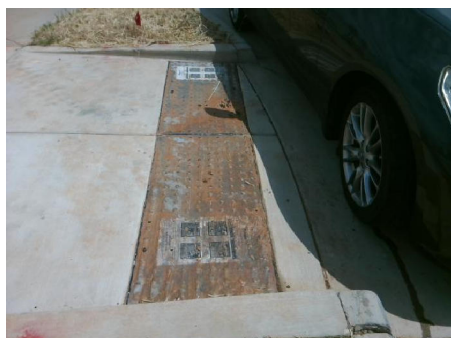
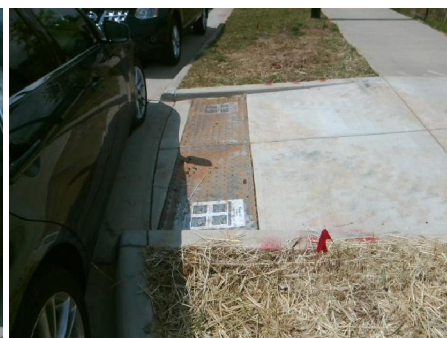
| ADA ID: 027F705BD84D | Ramp Type: Directional1 | Initial Pass/Fail: Pass | Overall Compliance: No |

**R304.5.3, R304.2.2-Perp, R304.3.2-  
Para, R305.1.4, R302.7, R302.7.2**

| Compliance | Description | Data | Compliance | Description | Data |
|---|---|---|---|---|---|
| No | Ramp XSlope (%) | 3.5 | | | |
| No | Landing Slope (%) | 3.1 | Yes | DWS Length (in) | 24.0 |
| No | Landing X Slope (%) | 2.1 | No | DWS Full Width? | No |
| No | Gutter Ponding? | Yes | Yes | Gutter Slope (%) | 1.5 |
| No | Gutter Lip Ht (in) | 1.0 | No | Gutter X Slope (%) | 2.8 |

**Remove & Replace Entire Ramp.  
Remove & Replace Gutter.**
