Access Compliance Report

Public Rights-of-Way

(Curb Ramps)

Intersection ID: 15820	Main Street: BURKLAND_DR	Cross Street: RODMAN_ST	Location: S
ADA ID: 0285C0341916	Ramp Type: PerpDiag	Initial Pass/Fail: Fail	Overall Compliance: No
			Severity Score: 21.25

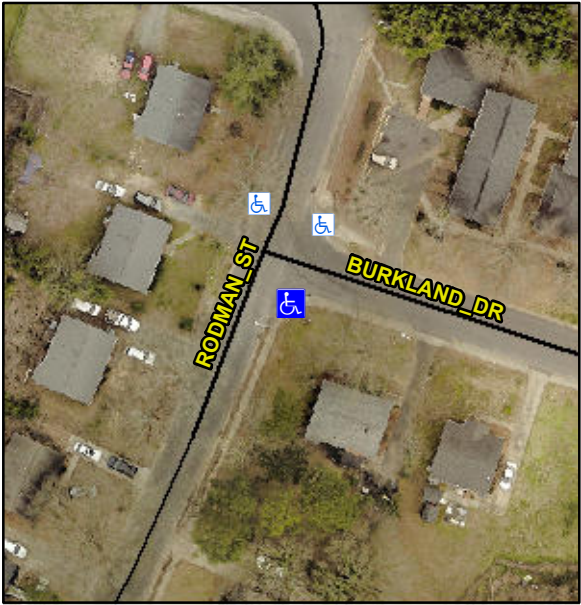
<p>Street 1 Name BURKLAND DR</p> <p>Stop Condition-Street 2 StopSign</p> <p>Street 2 Name RODMAN ST</p> <p>Stop Condition-Street 1 None</p>	Possible Solutions:		Compliance	Description	Data
	Remove & Replace Curb Ramp With Two New Directional Ramps or Equivalent.		Yes	Ramp Length (in)	50.0
			No	Ramp Width (in)	39.0
			N/A	Flare Type LT	N/A
			N/A	Flare Slope LT (%)	N/A
			N/A	Flare Traversable LT?	N/A
			N/A	Landing Length (in)	N/A
			N/A	Landing Width (in)	N/A
			N/A	Landing Slope (%)	N/A
			N/A	Landing X Slope (%)	N/A
			N/A	Landing Curb? (Y/N)	N/A
			N/A	Shared Landing?	N/A
			N/A	Gutter Ponding?	N/A
			N/A	Gutter Lip Ht (in)	N/A
			No	Painted X Walk1?	No
				X Walk 1 Direction	To N
			N/A	X Walk 1 Width (in)	N/A
				X Walk 1 Slope (%)	3.8
				X Walk 1 X Slope (%)	1.6
			N/A	Ramp inside XWalk1?	N/A
<p>Surveyor Notes:</p> <p>N/A</p> <p>PROW/ADA:</p> <p>R304.5.1, R304.5.3</p>			N/A	Ramp Slope (%)	5.3

No	Ramp XSlope (%)	5.7
			N/A	Flare Type RT	N/A
			N/A	Flare Slope RT (%)	N/A
			N/A	Flare Traversable RT?	N/A
			N/A	DWS Provided?	N/A
			N/A	DWS Contrast?	N/A
			N/A	DWS Length (in)	N/A
			N/A	DWS Full Width?	N/A
			N/A	DWS Offset (in)	N/A
			N/A	Gutter Slope (%)	N/A
			N/A	Gutter X Slope (%)	N/A
			No	Painted X Walk2?	No
				X Walk 2 Direction	To W
			N/A	X Walk 2 Width (in)	N/A
				X Walk 2 Slope (%)	3.0
				X Walk 2 X Slope (%)	3.8
			N/A	Ramp inside XWalk2?	N/A
			N/A	Clear Space?	N/A
			N/A	Clear Space to XWalk (in)	N/A
<p>Total Cost: \$ 3200.00</p>			N/A	Storm Grate/Utility Hazard?	N/A
				Storm Grate/Utility Type	
			N/A		N/A
			Yes	Surface Condition? (G/P)	Good
