# Access Compliance Report

## Public Rights-of-Way

### (Curb Ramps)

Intersection ID: 7965	Main Street: BROOKWAY_DR	Cross Street: S_RAMSEY_ST	Location: S
ADA ID: 0287D9B2A0CF	Ramp Type: Perp	Initial Pass/Fail: Fail	Overall Compliance: No
Severity Score: 21.25			
Codes/Mitigation Info/Possible Solution		Field Measurements/Component Compliance

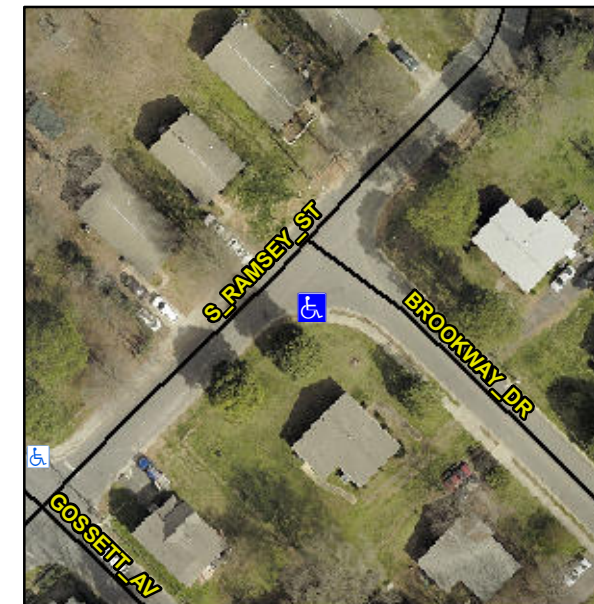
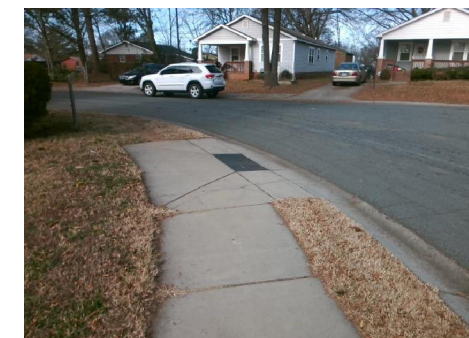
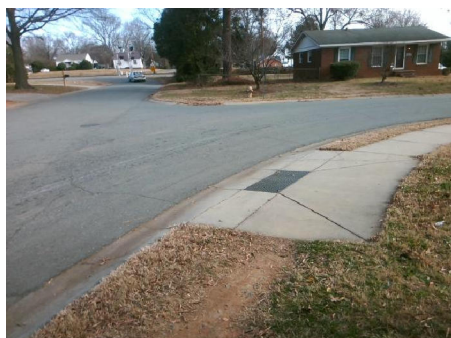
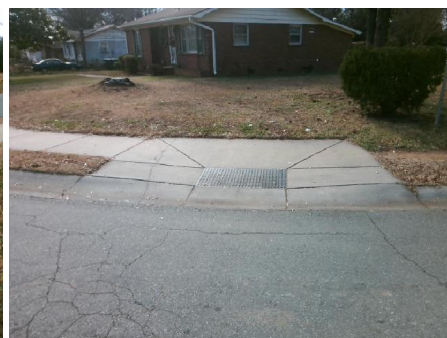
**Not Found, R304.5.1, R304.2.2**

Compliance	Description	Data	Compliance	Description	Data
N/A	Ramp Length (in)	53.5	No	Ramp Slope (%)	8.4
No	Ramp Width (in)	47.0	Yes	Ramp XSlope (%)	0.8
N/A	Flare Type LT	N/A	N/A	Flare Type RT	N/A
N/A	Flare Slope LT (%)	N/A	N/A	Flare Slope RT (%)	N/A
N/A	Flare Traversable LT?	N/A	N/A	Flare Traversable RT?	N/A
N/A	Landing Length (in)	N/A	N/A	DWS Provided?	N/A
N/A	Landing Width (in)	N/A	N/A	DWS Contrast?	N/A
N/A	Landing Slope (%)	N/A	N/A	DWS Length (in)	N/A
N/A	Landing X Slope (%)	N/A	N/A	DWS Full Width?	N/A
N/A	Landing Curb? (Y/N)	N/A	N/A	DWS Offset (in)	N/A
N/A	Shared Landing?	N/A			
N/A	Gutter Ponding?	N/A	N/A	Gutter Slope (%)	N/A
N/A	Gutter Lip Ht (in)	N/A	N/A	Gutter X Slope (%)	N/A
N/A	Painted X Walk1?	No	N/A	Painted X Walk2?	N/A
	X Walk 1 Direction	To NE		X Walk 2 Direction	N/A
N/A	X Walk 1 Width (in)	N/A	N/A	X Walk 2 Width (in)	N/A
	X Walk 1 Slope (%)	2.9		X Walk 2 Slope (%)	N/A
	X Walk 1 X Slope (%)	0.6		X Walk 2 X Slope (%)	N/A

N/A	Ramp inside XWalk1?	N/A	N/A	Ramp inside XWalk2?	N/A
	Road Slope (%)	0.6	N/A	Clear Space?	N/A
	Road X Slope (%)	2.9	N/A	Clear Space to XWalk (in)	N/A
N/A	Any Obstructions?	N/A	N/A	Storm Grate/Utility Hazard?	N/A
	Obstruction Type			Storm Grate/Utility Type	
		N/A			N/A
			Yes	Surface Condition? (G/P)	Good

**Remove & Replace Entire Ramp.**

**\$ 1850.00**
