Access Compliance Report

Public Rights-of-Way

(Curb Ramps)

Intersection ID: 29216	Main Street: BAUCOM_RD	Cross Street: BRATHAY_CT	Location: SW
ADA ID: 029D412FA9F4	Ramp Type: Perp	Initial Pass/Fail: Fail	Overall Compliance: No
Severity Score: 21.25			
Codes/Mitigation Info/Possible Solution		Field Measurements/Component Compliance

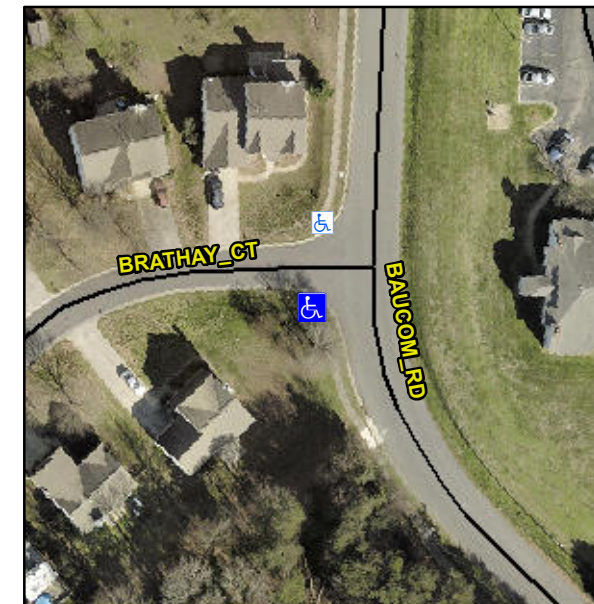
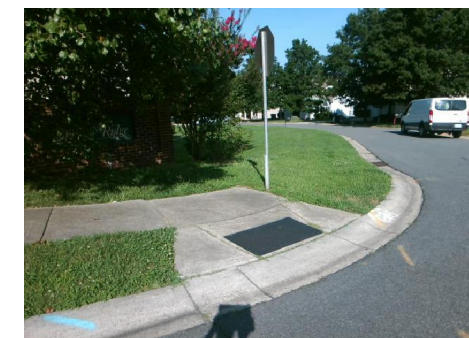
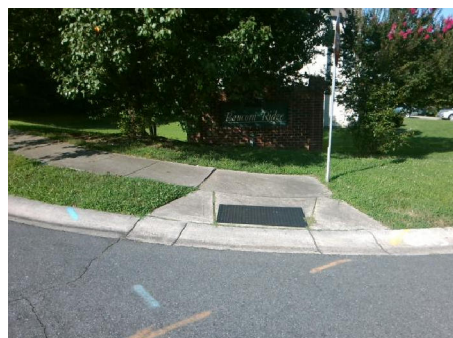
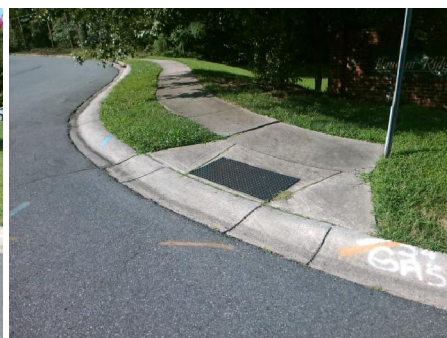
Not Found, R304.5.1, R304.5.3

Compliance	Description	Data	Compliance	Description	Data
N/A	Ramp Length (in)	45.5	Yes	Ramp Slope (%)	5.5
No	Ramp Width (in)	47.0	No	Ramp XSlope (%)	6.7
N/A	Flare Type LT	N/A	N/A	Flare Type RT	N/A
N/A	Flare Slope LT (%)	N/A	N/A	Flare Slope RT (%)	N/A
N/A	Flare Traversable LT?	N/A	N/A	Flare Traversable RT?	N/A
N/A	Landing Length (in)	N/A	N/A	DWS Provided?	N/A
N/A	Landing Width (in)	N/A	N/A	DWS Contrast?	N/A
N/A	Landing Slope (%)	N/A	N/A	DWS Length (in)	N/A
N/A	Landing X Slope (%)	N/A	N/A	DWS Full Width?	N/A
N/A	Landing Curb? (Y/N)	N/A	N/A	DWS Offset (in)	N/A
N/A	Shared Landing?	N/A			
N/A	Gutter Ponding?	N/A	N/A	Gutter Slope (%)	N/A
N/A	Gutter Lip Ht (in)	N/A	N/A	Gutter X Slope (%)	N/A
N/A	Painted X Walk1?	No	N/A	Painted X Walk2?	N/A
	X Walk 1 Direction	To N		X Walk 2 Direction	N/A
N/A	X Walk 1 Width (in)	N/A	N/A	X Walk 2 Width (in)	N/A
	X Walk 1 Slope (%)	3.1		X Walk 2 Slope (%)	N/A
	X Walk 1 X Slope (%)	7.1		X Walk 2 X Slope (%)	N/A

N/A	Ramp inside XWalk1?	N/A	N/A	Ramp inside XWalk2?	N/A
	Road Slope (%)	N/A	N/A	Clear Space?	N/A
	Road X Slope (%)	N/A	N/A	Clear Space to XWalk (in)	N/A
N/A	Any Obstructions?	N/A	N/A	Storm Grate/Utility Hazard?	N/A
	Obstruction Type			Storm Grate/Utility Type	
		N/A			N/A
			Yes	Surface Condition? (G/P)	Good

Remove & Replace Entire Ramp.
