Access Compliance Report

Public Rights-of-Way

(Curb Ramps)

Intersection ID: N/A	Main Street: ROUNDING_RUN_LN	Cross Street: WOODFOX_DR	Location: NW
ADA ID: 02A40F80A037	Ramp Type: BlendTrans2	Initial Pass/Fail: Fail	Overall Compliance: No
		Severity Score: 12.5

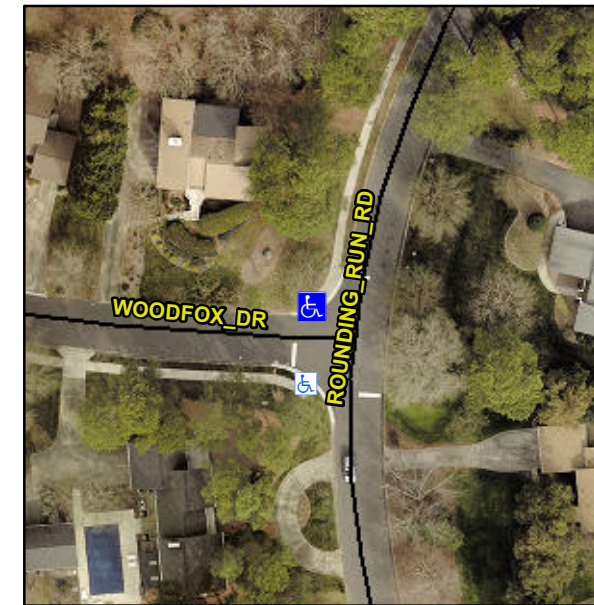
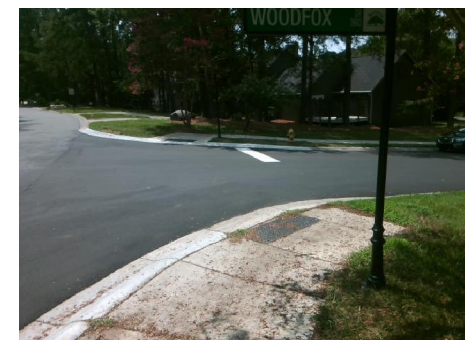
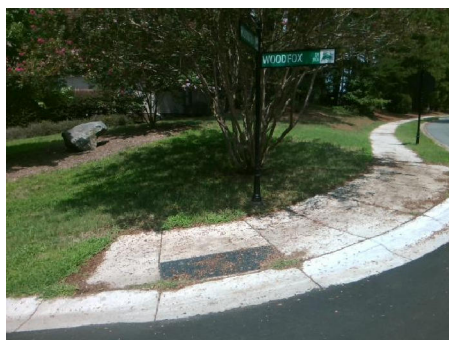
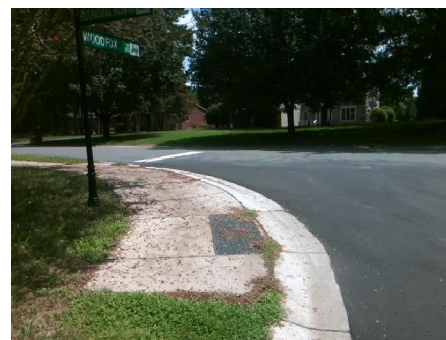
Not Found, R304.5.3

Compliance	Description	Data	Compliance	Description	Data
N/A	Ramp Length (in)	72.0	Yes	BlendTrans Slope (%)	1.3
Yes	Ramp Width (in)	53.0	No	BlendTrans XSlope (%)	6.7
N/A	Flare Type LT	N/A	N/A	Flare Type RT	N/A
N/A	Flare Slope LT (%)	N/A	N/A	Flare Slope RT (%)	N/A
N/A	Flare Traversable LT?	N/A	N/A	Flare Traversable RT?	N/A
N/A	Landing Length (in)	N/A	N/A	DWS Provided?	N/A
N/A	Landing Width (in)	N/A	N/A	DWS Contrast?	N/A
N/A	Landing Slope (%)	N/A	N/A	DWS Length (in)	N/A
N/A	Landing X Slope (%)	N/A	N/A	DWS Full Width?	N/A
N/A	Landing Curb? (Y/N)	N/A	N/A	DWS Offset (in)	N/A
N/A	Shared Landing?	N/A			
N/A	Gutter Ponding?	N/A	N/A	Gutter Slope (%)	N/A
N/A	Gutter Lip Ht (in)	N/A	N/A	Gutter X Slope (%)	N/A
N/A	Painted X Walk1?	No	N/A	Painted X Walk2?	No
	X Walk 1 Direction	To S		X Walk 2 Direction	To E
	X Walk 1 Width (in)	N/A		X Walk 2 Width (in)	N/A
	X Walk 1 Slope (%)	1.7		X Walk 2 Slope (%)	1.6
	X Walk 1 X Slope (%)	9.6		X Walk 2 X Slope (%)	3.3

N/A	Ramp inside XWalk1?	N/A	N/A	Ramp inside XWalk2?	N/A
	Road Slope (%)	6.1		Clear Space?	N/A
	Road X Slope (%)	8.8	N/A	Clear Space to XWalk (in)	N/A
N/A	Any Obstructions?	N/A	N/A	Storm Grate/Utility Hazard?	N/A
	Obstruction Type			Storm Grate/Utility Type	
		N/A			N/A
			Yes	Surface Condition? (G/P)	Good
			No	Curb Slope (%)	5.4

Remove & Replace Curb Ramp With Two New Directional Ramps or Equivalent.
