# Access Compliance Report

## Public Rights-of-Way

Intersection ID: 49131	Main Street: EWERT_CUT_LN	Cross Street: WILTSHIRE_RIDGE_RD	Location: SE
ADA ID: 02A7321915EF	Ramp Type: Perp	Initial Pass/Fail: Pass	Overall Compliance: No
Codes/Mitigation Info/Possible Solution		Field Measurements/Component Compliance	
Severity Score: 2.5

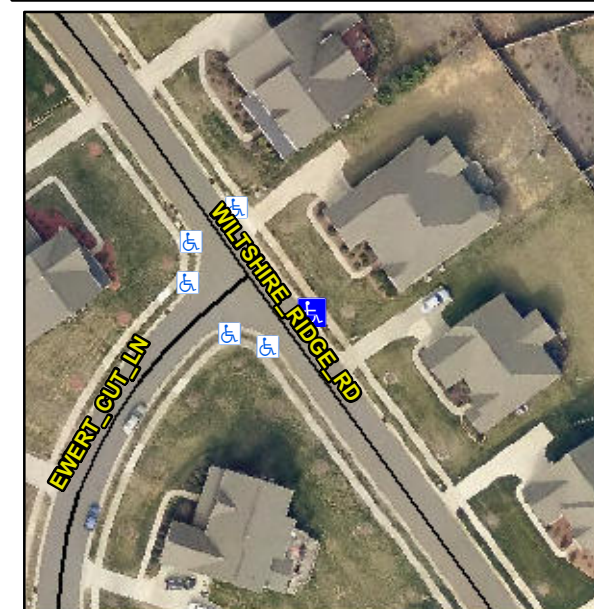
Compliance	Description	Data	Compliance	Description	Data
N/A	Ramp Length (in)	46.5	Yes	Ramp Slope (%)	6.9
Yes	Ramp Width (in)	48.0	Yes	Ramp XSlope (%)	0.7
N/A	Flare Type LT	Sloped	N/A	Flare Type RT	N/A
N/A	Flare Slope LT (%)	10.2	Yes	Flare Slope RT (%)	2.8
N/A	Flare Traversable LT?	Yes	N/A	Flare Traversable RT?	Yes
No	Landing Length (in)	47.5	Yes	DWS Provided?	Yes
Yes	Landing Width (in)	50.0	Yes	DWS Contrast?	Yes
No	Landing Slope (%)	3.5	Yes	DWS Length (in)	24.5
Yes	Landing X Slope (%)	3.1	Yes	DWS Full Width?	Yes
N/A	Landing Curb? (Y/N)	No	No	DWS Offset (in)	4.0
N/A	Shared Landing?	No			
Yes	Gutter Ponding?	No	Yes	Gutter Slope (%)	2.9
Yes	Gutter Lip Ht (in)	0.0	Yes	Gutter X Slope (%)	3.6
N/A	Painted X Walk1?	No	N/A	Painted X Walk2?	N/A
	X Walk 1 Direction	To W		X Walk 2 Direction	N/A
N/A	X Walk 1 Width (in)	N/A	N/A	X Walk 2 Width (in)	N/A
	X Walk 1 Slope (%)	3.3		X Walk 2 Slope (%)	N/A
	X Walk 1 X Slope (%)	4.9		X Walk 2 X Slope (%)	N/A

N/A	Ramp inside XWalk1?	N/A	N/A	Ramp inside XWalk2?	N/A
	Road Slope (%)	N/A	N/A	Clear Space?	Yes
	Road X Slope (%)	N/A	N/A	Clear Space to XWalk (in)	N/A
Yes	Any Obstructions?	No	Yes	Storm Grate/Utility Hazard?	No
	Obstruction Type			Storm Grate/Utility Type	
		N/A			N/A
			Yes	Surface Condition? (G/P)	Good

**Remove & Replace Entire Ramp.**
