# Access Compliance Report

## Public Rights-of-Way

| Intersection ID: 15215 | Main Street: HARRISBURG_RD | Cross Street: OLD_MEADOW_RD | Location: NW |
| ADA ID: 02BB96C12AC5 | Ramp Type: Perp | Initial Pass/Fail: Fail | Overall Compliance: No |

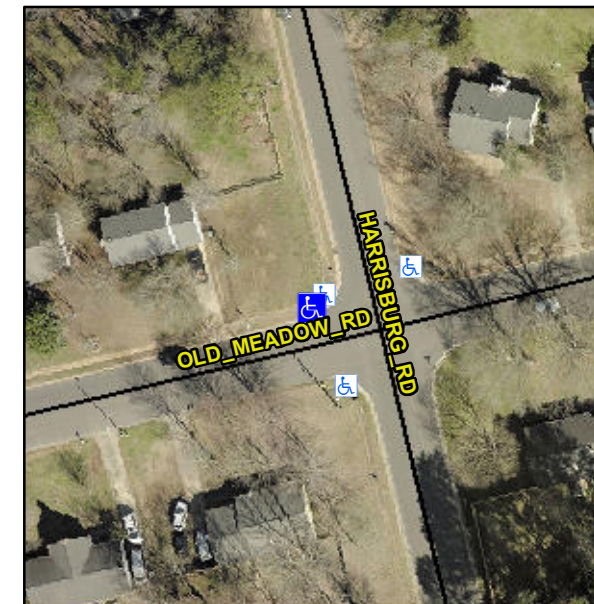
| | | Severity Score: 25 | |

| Compliance | Description | Data | Compliance | Description | Data |
|---|---|---|---|---|---|
| N/A | Ramp Length (in) | 78.0 | No | Ramp Slope (%) | 10.0 |
| Yes | Ramp Width (in) | 48.0 | No | Ramp XSlope (%) | 5.9 |

**Remove & Replace Entire Ramp.**

**R304.2.2, R304.5.3**

Total Cost: \$ 1850.00
