Access Compliance Report

Public Rights-of-Way

(Curb Ramps)

Intersection ID: 19900	Main Street: KEELING_PL	Cross Street: NETHERWOOD_DR	Location: NW
ADA ID: 02D3F9C8383D	Ramp Type: Perp	Initial Pass/Fail: Fail	Overall Compliance: No
Severity Score: 25			
Codes/Mitigation Info/Possible Solution		Field Measurements/Component Compliance

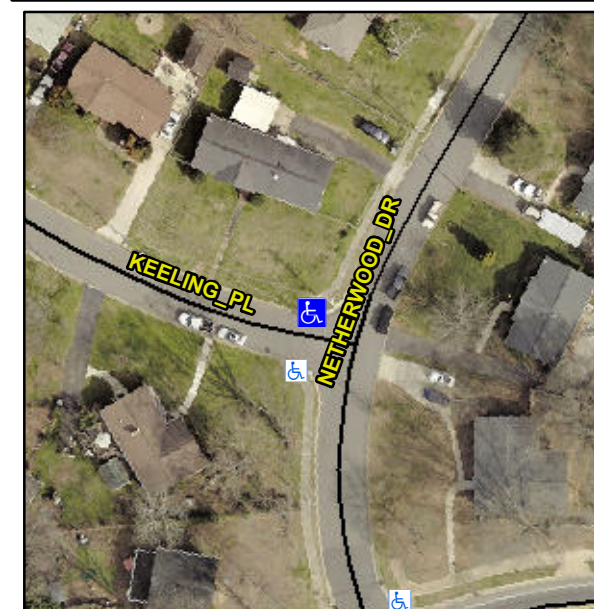
Not Found, R304.2.2, R304.5.3

Compliance	Description	Data	Compliance	Description	Data
N/A	Ramp Length (in)	92.0	No	Ramp Slope (%)	10.7
Yes	Ramp Width (in)	48.0	No	Ramp XSlope (%)	5.6
N/A	Flare Type LT	N/A	N/A	Flare Type RT	N/A
N/A	Flare Slope LT (%)	N/A	N/A	Flare Slope RT (%)	N/A
N/A	Flare Traversable LT?	N/A	N/A	Flare Traversable RT?	N/A
N/A	Landing Length (in)	N/A	N/A	DWS Provided?	N/A
N/A	Landing Width (in)	N/A	N/A	DWS Contrast?	N/A
N/A	Landing Slope (%)	N/A	N/A	DWS Length (in)	N/A
N/A	Landing X Slope (%)	N/A	N/A	DWS Full Width?	N/A
N/A	Landing Curb? (Y/N)	N/A	N/A	DWS Offset (in)	N/A
N/A	Shared Landing?	N/A			
N/A	Gutter Ponding?	N/A	N/A	Gutter Slope (%)	N/A
N/A	Gutter Lip Ht (in)	N/A	N/A	Gutter X Slope (%)	N/A
N/A	Painted X Walk1?	No	N/A	Painted X Walk2?	N/A
	X Walk 1 Direction	To S		X Walk 2 Direction	N/A
N/A	X Walk 1 Width (in)	N/A	N/A	X Walk 2 Width (in)	N/A
	X Walk 1 Slope (%)	1.1		X Walk 2 Slope (%)	N/A
	X Walk 1 X Slope (%)	3.0		X Walk 2 X Slope (%)	N/A

N/A	Ramp inside XWalk1?	N/A	N/A	Ramp inside XWalk2?	N/A
	Road Slope (%)	N/A	N/A	Clear Space?	N/A
	Road X Slope (%)	N/A	N/A	Clear Space to XWalk (in)	N/A
N/A	Any Obstructions?	N/A	N/A	Storm Grate/Utility Hazard?	N/A
	Obstruction Type			Storm Grate/Utility Type	
		N/A			N/A
			Yes	Surface Condition? (G/P)	Good

Remove & Replace Entire Ramp.
