Access Compliance Report

Public Rights-of-Way

(Curb Ramps)

Intersection ID: 2490	Main Street: BENTGRASS_RUN_DR	Cross Street: LYLETON_LN	Location:	N
ADA ID: 02D442D261B9	Ramp Type: PerpDiag	Initial Pass/Fail: Fail	Overall Compliance: No	Severity Score: 12.5
Codes/Mitigation Info/Possible Solution		Field Measurements/Component Compliance

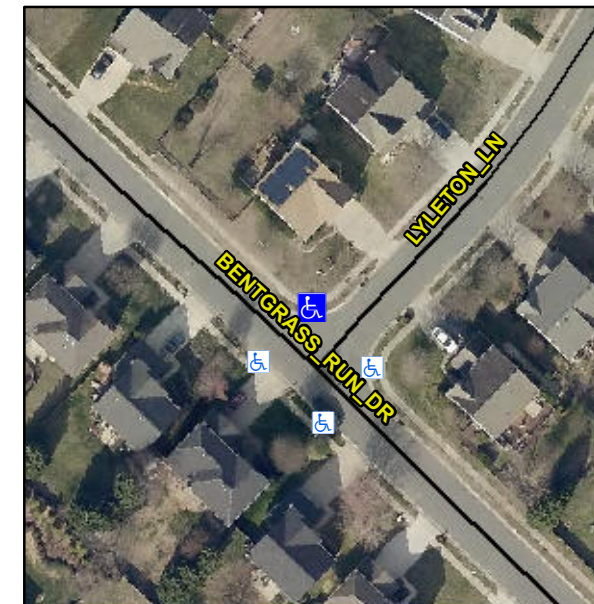
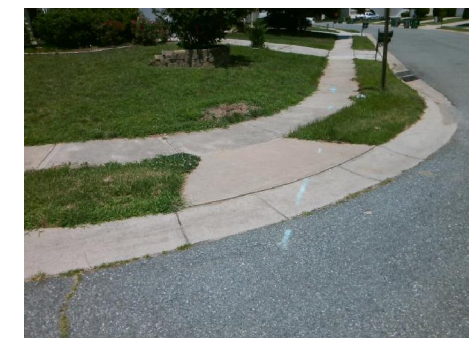
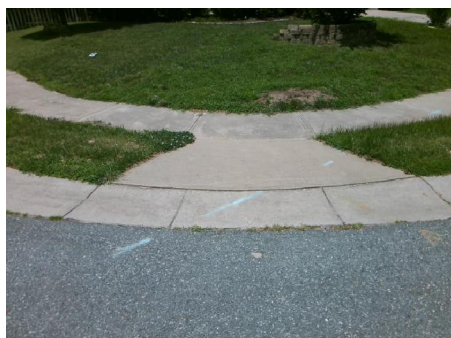
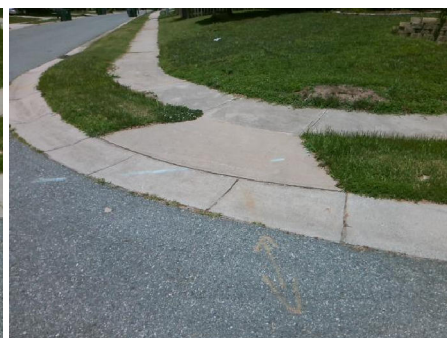
R304.2.2

Compliance	Description	Data	Compliance	Description	Data
N/A	Ramp Length (in)	45.0	No	Ramp Slope (%)	8.4
Yes	Ramp Width (in)	49.0	Yes	Ramp XSlope (%)	1.8
N/A	Flare Type LT	N/A	N/A	Flare Type RT	N/A
N/A	Flare Slope LT (%)	N/A	N/A	Flare Slope RT (%)	N/A
N/A	Flare Traversable LT?	N/A	N/A	Flare Traversable RT?	N/A
N/A	Landing Length (in)	N/A	N/A	DWS Provided?	N/A
N/A	Landing Width (in)	N/A	N/A	DWS Contrast?	N/A
N/A	Landing Slope (%)	N/A	N/A	DWS Length (in)	N/A
N/A	Landing X Slope (%)	N/A	N/A	DWS Full Width?	N/A
N/A	Landing Curb? (Y/N)	N/A	N/A	DWS Offset (in)	N/A
N/A	Shared Landing?	N/A			
N/A	Gutter Ponding?	N/A	N/A	Gutter Slope (%)	N/A
N/A	Gutter Lip Ht (in)	N/A	N/A	Gutter X Slope (%)	N/A
N/A	Painted X Walk1?	No	N/A	Painted X Walk2?	No
	X Walk 1 Direction	To SW		X Walk 2 Direction	To SE
N/A	X Walk 1 Width (in)	N/A	N/A	X Walk 2 Width (in)	N/A
	X Walk 1 Slope (%)	3.7		X Walk 2 Slope (%)	1.2
	X Walk 1 X Slope (%)	1.2		X Walk 2 X Slope (%)	4.0

N/A	Ramp inside XWalk1?	N/A	N/A	Ramp inside XWalk2?	N/A
	Road Slope (%)	3.8	N/A	Clear Space?	N/A
	Road X Slope (%)	1.2	N/A	Clear Space to XWalk (in)	N/A
N/A	Any Obstructions?	N/A	N/A	Storm Grate/Utility Hazard?	N/A
	Obstruction Type			Storm Grate/Utility Type	
		N/A			N/A
			Yes	Surface Condition? (G/P)	Good

Remove & Replace Curb Ramp With Two New Directional Ramps or Equivalent.

\$ 3200.00
