Access Compliance Report

Public Rights-of-Way

(Curb Ramps)

Intersection ID: 10034609	Main Street: PLANTATION_CENTER_DR	Cross Street: N/A	Location: S
ADA ID: 02DB41E0A955	Ramp Type: Para	Initial Pass/Fail: Fail	Overall Compliance: No
Codes/Mitigation Info/Possible Solution		Field Measurements/Component Compliance	
Severity Score: 26.25

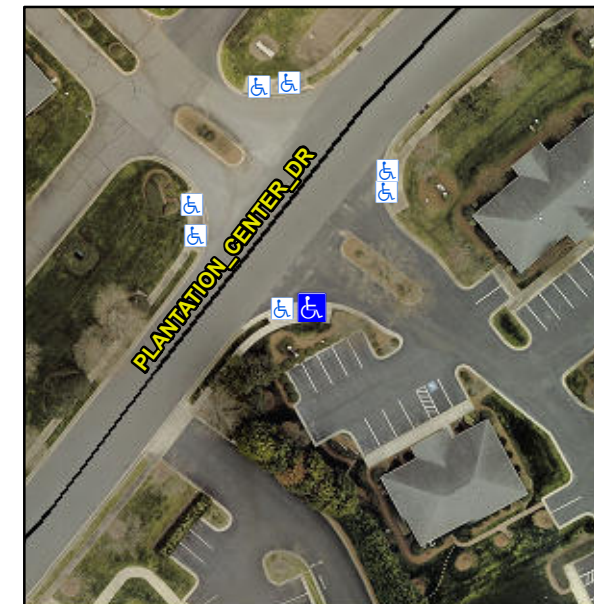
R304.3.2, R304.5.3

Compliance	Description	Data	Compliance	Description	Data
N/A	Ramp Length LT (in)	54.0	N/A	Ramp Length RT (in)	62.0
Yes	Ramp Width LT (in)	96.0	Yes	Ramp Width RT (in)	96.0
No	Ramp Slope LT (%)	14.0	Yes	Ramp Slope RT (%)	6.8
No	Ramp XSlope LT (%)	2.3	No	Ramp XSlope RT (%)	2.8
N/A	Landing Length (in)	N/A	N/A	DWS Provided?	N/A
N/A	Landing Width (in)	N/A	N/A	DWS Contrast?	N/A
N/A	Landing Slope (%)	N/A	N/A	DWS Length (in)	N/A
N/A	Landing X Slope (%)	N/A	N/A	DWS Full Width?	N/A
N/A	Landing Curb? (Y/N)	N/A	N/A	DWS Offset (in)	N/A
N/A	Shared Landing?	N/A			
N/A	Gutter Ponding?	N/A	N/A	Gutter Slope (%)	N/A
N/A	Gutter Lip Ht (in)	N/A	N/A	Gutter X Slope (%)	N/A
N/A	Painted X Walk1?	No	N/A	Painted X Walk2?	N/A
	X Walk 1 Direction	To NE		X Walk 2 Direction	N/A
N/A	X Walk 1 Width (in)	N/A	N/A	X Walk 2 Width (in)	N/A
	X Walk 1 Slope (%)	0.2		X Walk 2 Slope (%)	N/A
	X Walk 1 X Slope (%)	1.9		X Walk 2 X Slope (%)	N/A
N/A	Ramp inside XWalk1?	N/A	N/A	Ramp inside XWalk2?	N/A

Road Slope (%)	N/A	N/A	Clear Space?	N/A
	Road X Slope (%)	N/A	N/A	Clear Space to XWalk (in)	N/A
N/A	Any Obstructions?	N/A	N/A	Storm Grate/Utility Hazard?	N/A
	Obstruction Type			Storm Grate/Utility Type	
		N/A			N/A
			Yes	Surface Condition? (G/P)	Good
			N/A	Curb Slope (%)	9.5

Possible Solutions:

Remove & Replace Entire Ramp.
